**Inuvik to Tuktoyaktuk Highway –
Terrain and Permafrost Field
Verification Program**

FINAL REPORT

August 31, 2012

KAVIK-STANTEC INC.
Inuvik, NT and Calgary, Alberta

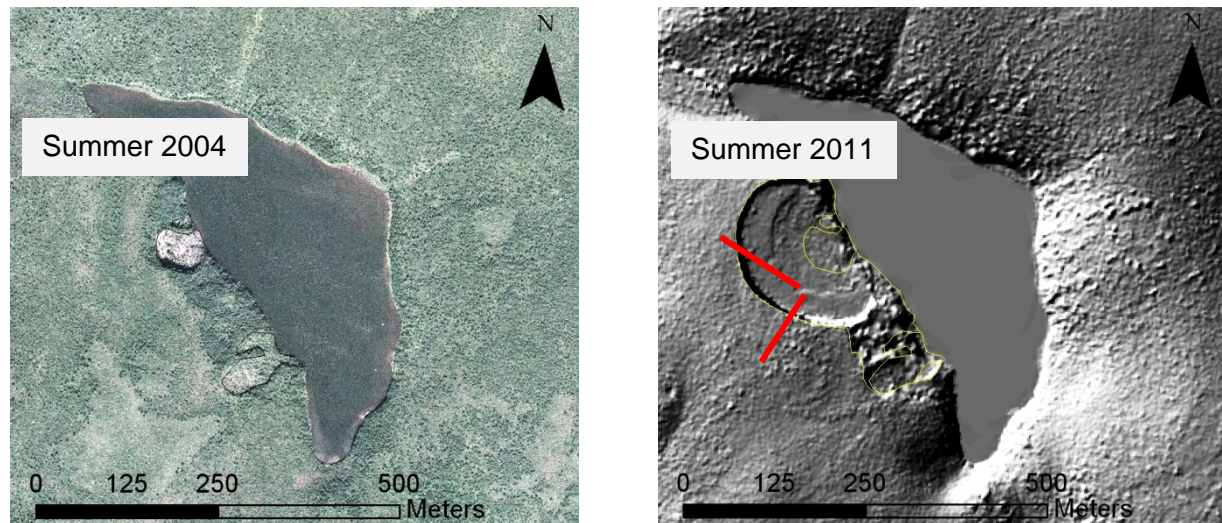
A series of ground-penetrating radar (GPR) profiles were collected along the crest of the slump area (Figure 3-2). Although visual assessment of the scarp face proposes that there is a sharp contact with massive ice at an approximate depth of 2 m, no strong reflectors corresponding to the top of the massive ice are discernible on the GPR profiles. This seems to suggest that there was little contrast at this site between the soil immediately below the active layer and the massive ice that is thawing out. It also suggests that ice-rich soils are present from the base of the active layer all the way down to the inferred depth of the massive ice between 7 to 10 m depth (based on GPR data).

*Approximate locations of the GPR transects in red

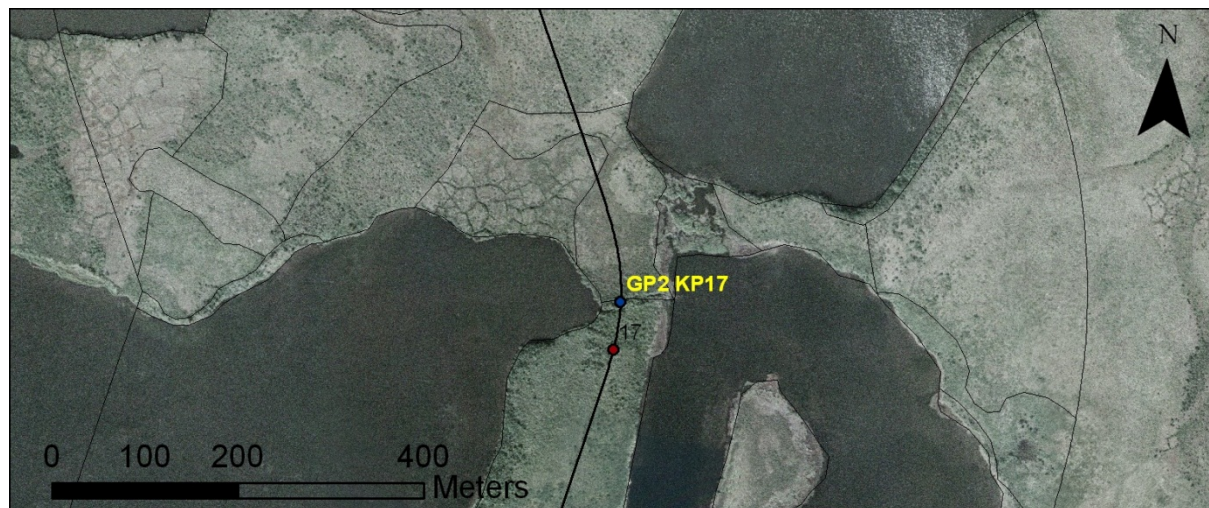
Figure 3-3 Location of site GP2 KP17

At site GP2 KP17, the alignment is located along a narrow, low-lying ridge separating two lakes (Figure 3-3). This site was selected to investigate the local conditions along an area where poor drainage and thermokarst degradation could possibly be an issue in the future.

The GPR profile collected along the proposed route alignment at the creek crossing provided a relatively good signal penetration on the ground located on either side of the creek, which indicates well frozen, likely ice rich, soils. Within the creek itself the GPR signal is significantly attenuated to the extent that little penetration into the soils is achieved using the GPR. This illustrated the influence temperature and ice content has on the attenuation rate in fine grained soils and this is one of the signatures used in interpreting GPR data for thawed taliks. Another feature of interest that is seen on the GPR profile is the obvious increase in active layer thickness as the creek is approached.

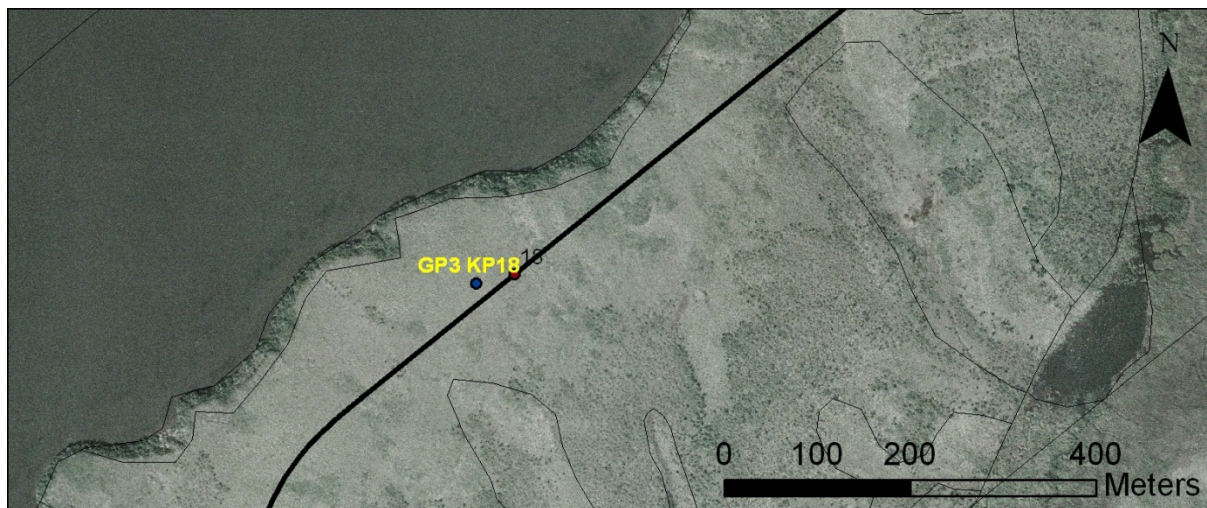
Figure 3-4 Location of site GP3 KP18

Site GP3 KP18 consists of a flat to very gently undulating till deposit. From KP 17.7 to KP 18.5 the proposed alignment is located at close proximity (i.e. from 60 to 120m) to a lake shoreline (Figure 3-4). Airphoto interpretations as well as field observations indicate that the shoreline is characterized by a series of small landslides and therefore is thaw unstable. No exposed soils and fresh landslide scars were identified on site but clear signs of past landslide activity can be observed along the shoreline (Appendix A, Photo A-4).

The OhmMapper data in particular showed very resistive materials in the top 1.5 to 2.75m, suggesting high ice content material immediately below the active layer. This was confirmed by the shallow borehole drilling that was conducted onsite. A very sharp contact between the top soil and ice was encountered at 35 cm below ground level. Clear ice was encountered from 35 cm to approx. 45 cm depth (Appendix A, Photo A-5). Material found between 45 cm and 90 cm showed as much as 60% ice content.

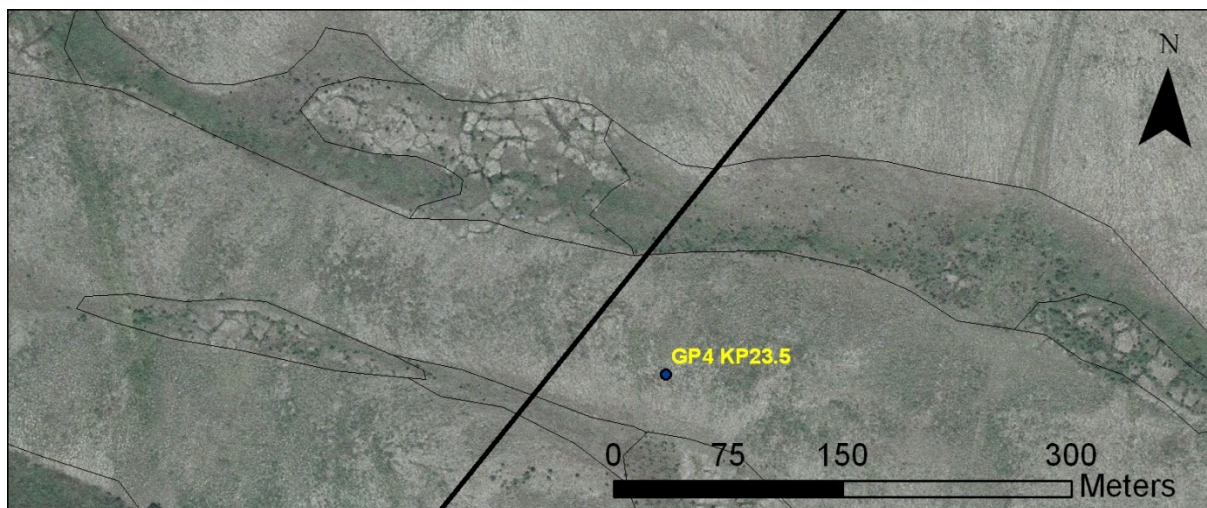
Figure 3-5 Drainage channels at site GP4 KP23.5

Site GP4 KP23.4 is located on undulating till plain (Figure 3-5). Slopes are very gentle and range from flat to a maximum of 4%. The features of interest at this location are the presence of a series of shallow drainage channels intersecting the proposed route alignment. The channels range in width from a few meters to approximately 125 m. Surface drainage within the channels is generally very poor, with strong seasonal seepage flowing from west to east. The thickness of the organic accumulations is generally thicker with the channels. Some of the larger channels are characterized by well defined, ephemeral creeks but the vast majority of them are characterized by undefined flow path. The distinct vegetation cover found within the drainage paths is as a key indicator of their lateral extent, therefore facilitating the delineation of the channels during the terrain mapping exercise (Appendix A, Photo A-6).

One GPR profile and one OhmMapper profile were collected at this location. The interest in conducting a geophysical survey at this specific site was to assess its utility in refining the mapping of the main drainage path in areas of low topographic relief, knowing that culvert placement is a key factor that could affect the integrity of the road infrastructure. Results of both geophysical methods clearly identify where the low-lying, ice-rich, high moisture materials are located. In addition to identifying concentrations of water, the GPR data showed a series of very narrow reflections that in the field were noted to correlate with surface cracks that could be possible, poorly developed, ice wedge features.

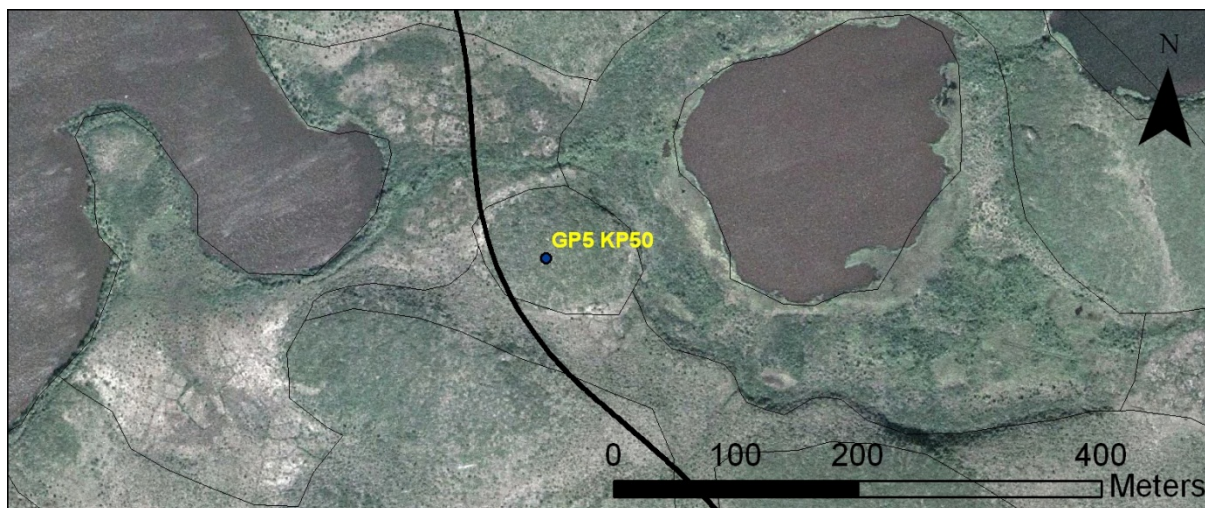
Figure 3-6 Location of site GP5 KP50

Site GP5 KP50 is characterized by a succession of various terrain types (i.e. till, to glaciofluvial outwash, to lacustrine deposits; Figure 3-6). Slopes are variable and range from 2 to 10% on top of the till and lacustrine deposits, to a maximum of 25% along the edges of the glaciofluvial outwash units (Appendix A, Photo A-8). The drainage of the various parent materials range from moderately well to poor and is directly related to factors such as the various material textures, their topographic positions, slope and aspects.

Both a GPR and OhmMapper profiles were collected at this site. The main interest of the geophysical surveys at this location was to see how the geophysics would characterized the changes in the surface materials as the system passes from one terrain unit to another. Neither the GPR nor the OhmMapper data indicate a clear transition between the various terrain units. Although no lateral material transition was interpreted from the geophysical data, rather high ice contents were noted in the in the upper surface

materials, as well as in a specific area located at the base of a north facing slope where large ice-wedges were present. In addition, a strong vertical reflector was noted at an approximate depth of two meters below the surface.

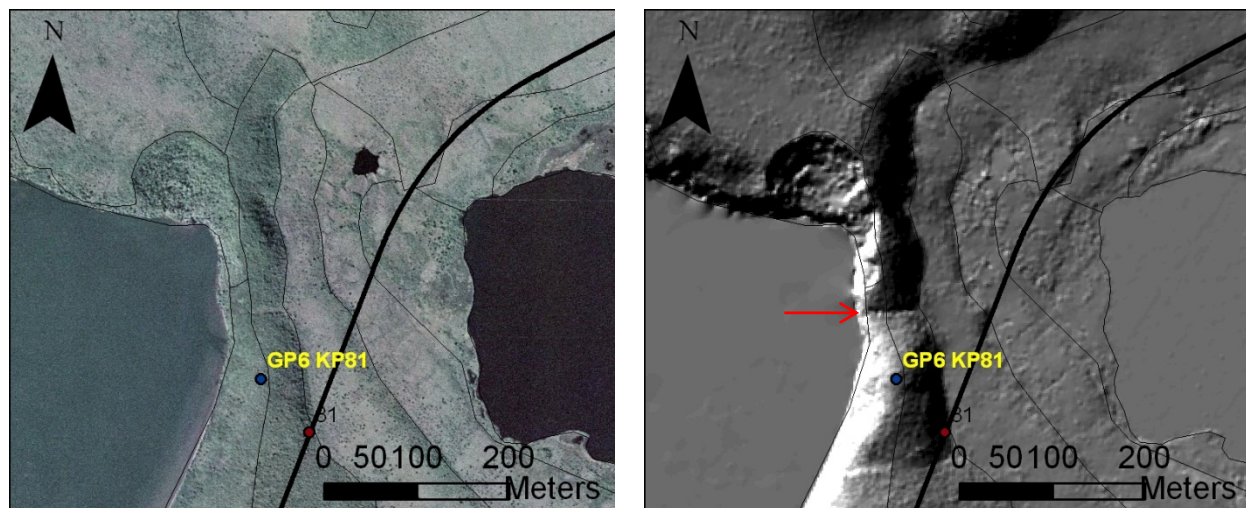
Figure 3-7 Airphoto and Lidar data of site GP6 KP81.

A retrogressive thaw flow slide is located at the northwestern extremity of the ridge. The landslide has a typical arcuate shape along its crest and covers an area of 100m²(1 ha) Both the field observations and the comparison of the landslide limits between the 2004 airphotos and the 2011 LiDAR data indicates that the landslide is stable and has not increased in size over the last seven years (Figure 3-7). The LiDAR data also indicates that the central portion of the ridge is characterized by a small depression, approximately 2m lower than the surrounding terrain (see the red arrow on Figure 3-7).

Three GPR profiles were collected at this location. One profile was along the ridge line, one was in the lacustrine material found along the toe of the ridge and the lake to the east, and the third was oriented perpendicular to the ridge, from the top of the ridge to the toe of the slope. The GPR profile along the ridge shows typical variations in active layer thickness and confirms that active drainage and a depressed

active layer are present at the depression area noted on the LiDAR data (red arrow). The GPR data in the lacustrine material at base of the ridge show significantly more signal penetration and likely higher ice content. Finally the GPR profile perpendicular to the ridgeline clearly shows that the transition between the till and the lacustrine material is located at the toe of the ridge.

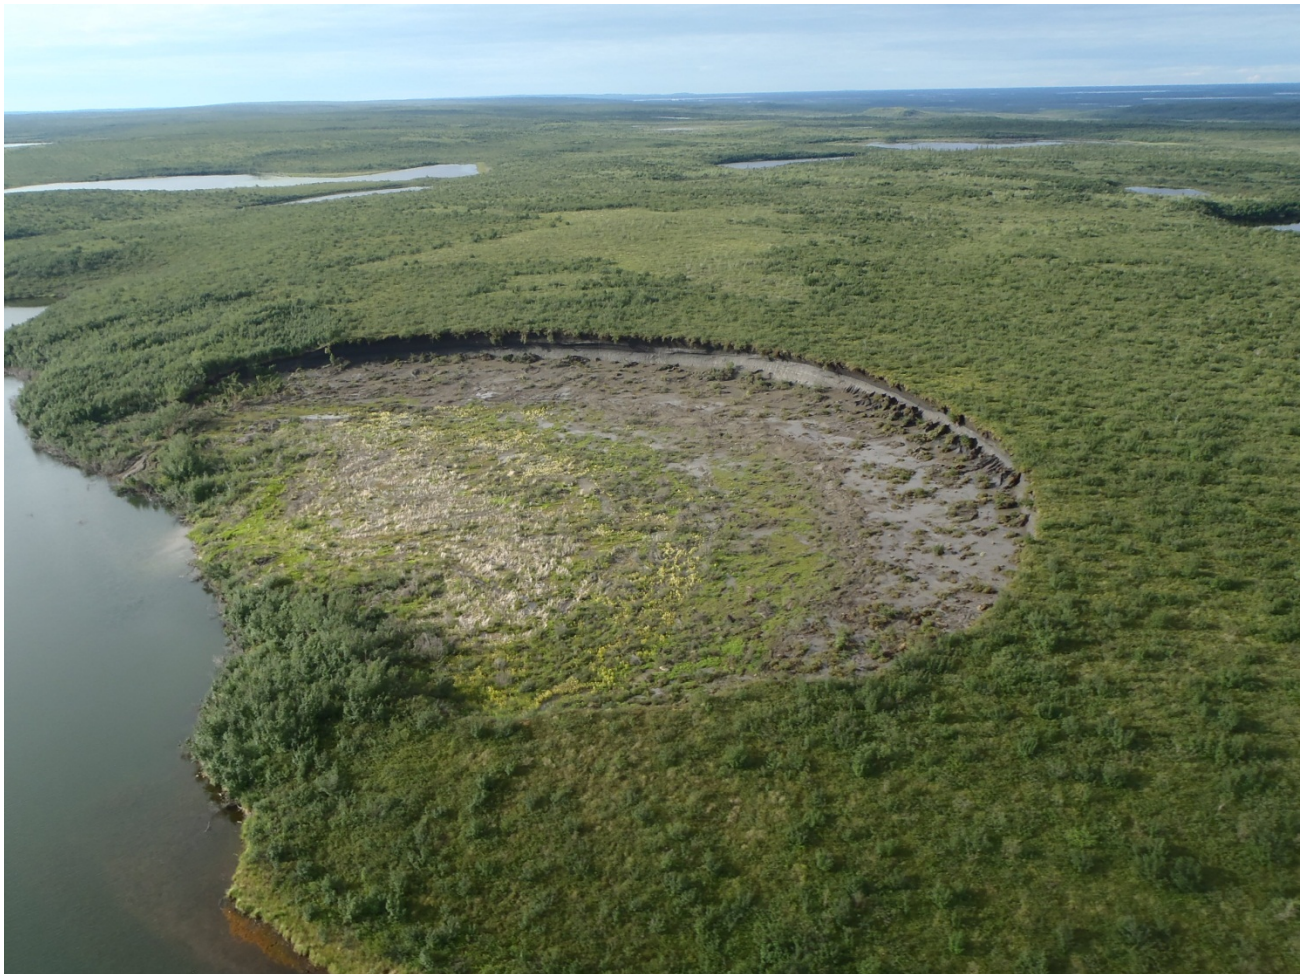
Site GP1 KP12.5 was selected in order to investigate a series of large retrogressive thaw flow slides approximately 800 m east of KP 12.5 (Appendix A, Photo A-1). This type of landslide is typical of fine-grained till material characterized by ice-rich permafrost. The process involves the thermal erosion of [surface] ground ice which leads to successive failures and flow of water saturated sediments (French 2007).

The retrogressive thaw flow slide east of KP12.5 has initiated along the west shore of a small lake in an area characterized by flat to very gently undulating till deposits. Slope gradients along the undisturbed portion of the area average 0 to 5%, with the exception of a short, 3 to 5 m incline along shoreline that can reach up to 60% grade.

Photo A-1 Large retrogressive thaw flow slide located approx. 800m east of the proposed alignment at KP 12.5

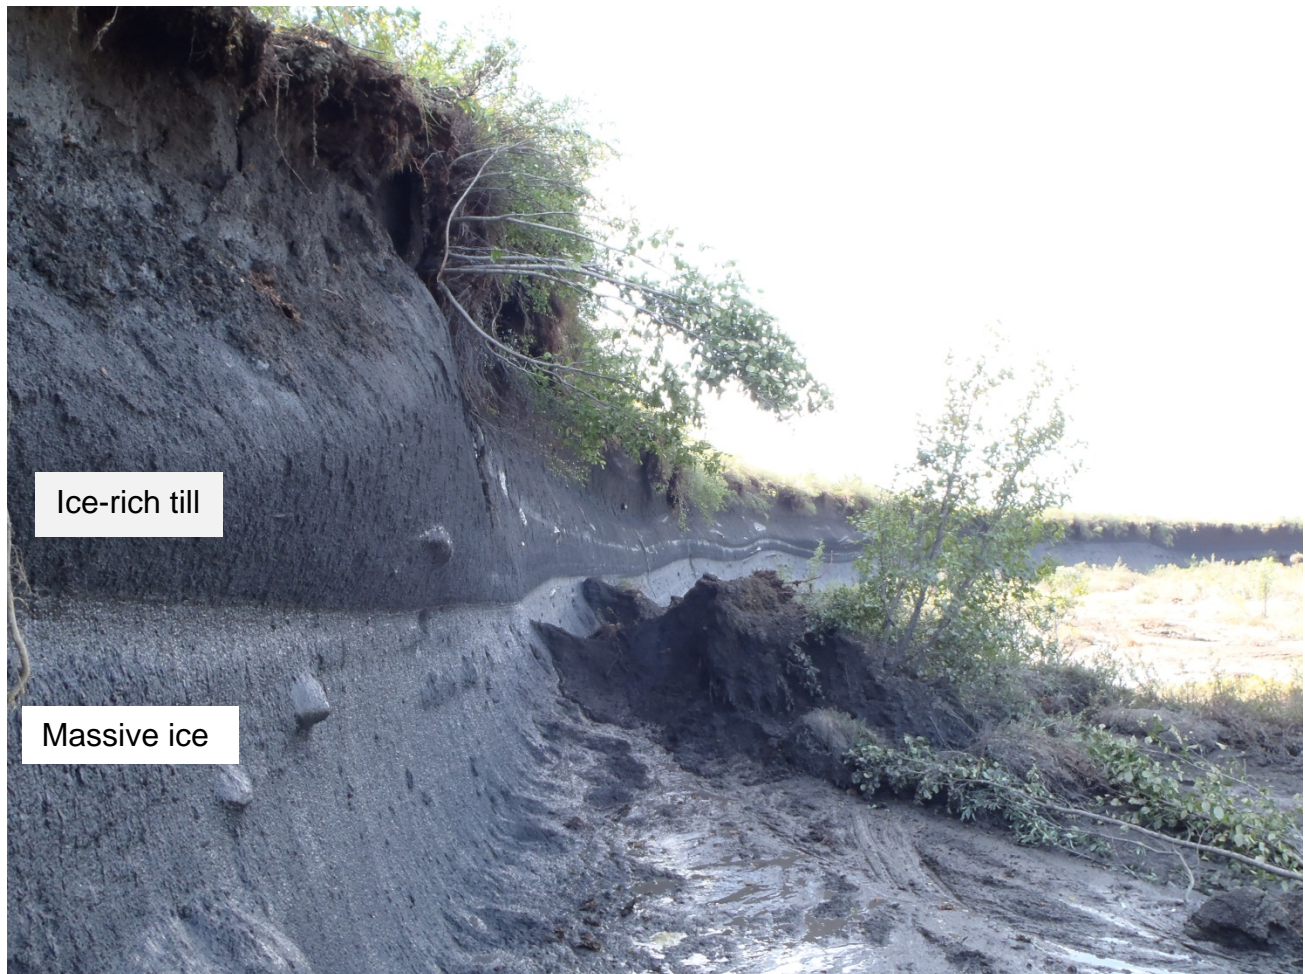
The material within the retrogressive thaw flow slide as well as along the scarp face indicates that the till found in the area consists mostly of silt and clay, with only a very minor portion of coarse fragments. The imperfect to poor site drainage and vegetation conditions are typical of the fine texture tills found in the area. Observation of the material along the 3 to 5m high scarp face clearly indicates the presence of massive ice at an approximate depth of 2 m below ground surface (Appendix A, Photo A-2).

Photo A-2 Steep headwall of a retrogressive thaw flow slide near KP 12.5. The height of the exposure ranges from 3 to 5m.

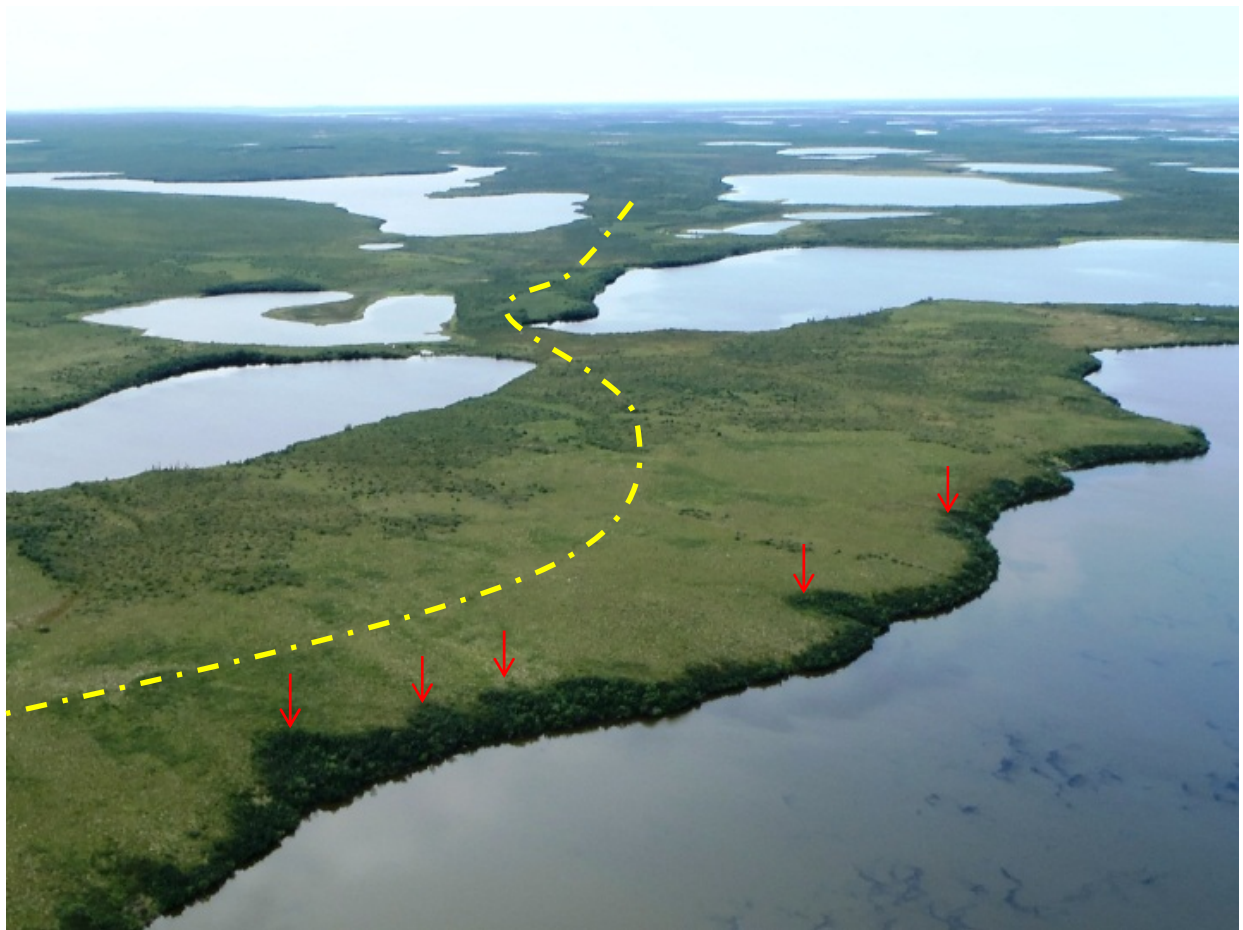
Photo A-4 Flat to gently undulating till deposit between KP 17 and KP 18 (route alignment in yellow, landslide scars in red).

18.1	Alignment less than 30 m from a receding shoreline affected by thermokarst and slumping	Verified. No recent signs of surface erosion or mass movement	Route optimization in an effort to follow ridge tops and maximize drainage will be evaluated in detailed design. Monitoring of shoreline conditions will be conducted.
19 to 19.3	Geometry could be improved to stay away from small creek	Verified	Route optimization in effort to move away from creek will be evaluated in detailed design
19 to 21	Signs of solifluction on several mid to lower slopes in the area	Verified. No solifluction features at proximity to the centerline	No action required
21 to 25	Alignment crosses a series of seven (7) undefined flow paths characterized by seepage, ice wedge polygons and organic accumulations	Verified. Geophysical investigation confirms where the low-lying, ice-rich, high moisture content are	Will be addressed by engineered mitigation during detailed design

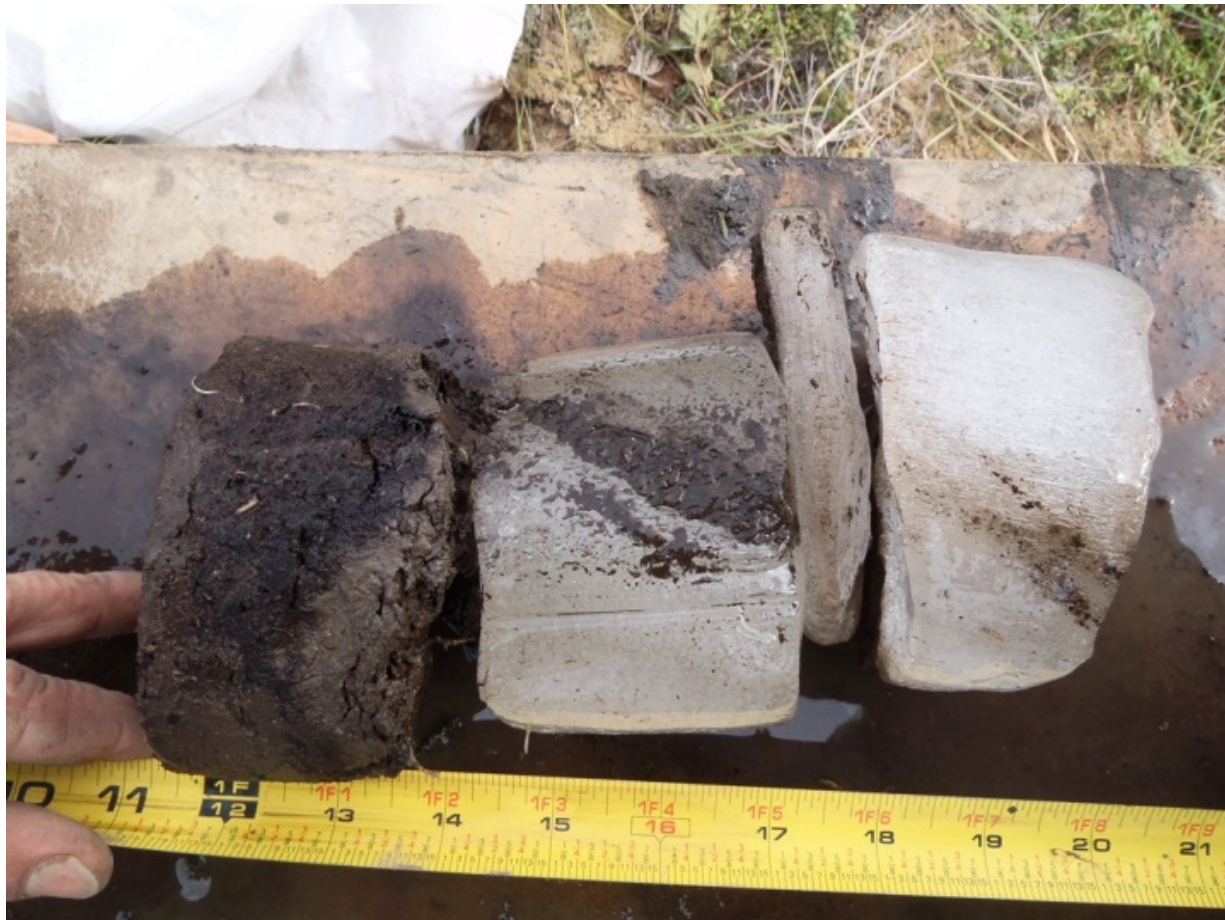
Photo A-5 Core sample showing sharp contact between the topsoil and ice at 35cm depth. Active layer depth was of 30cm on July 26 (sample depth are in inches).

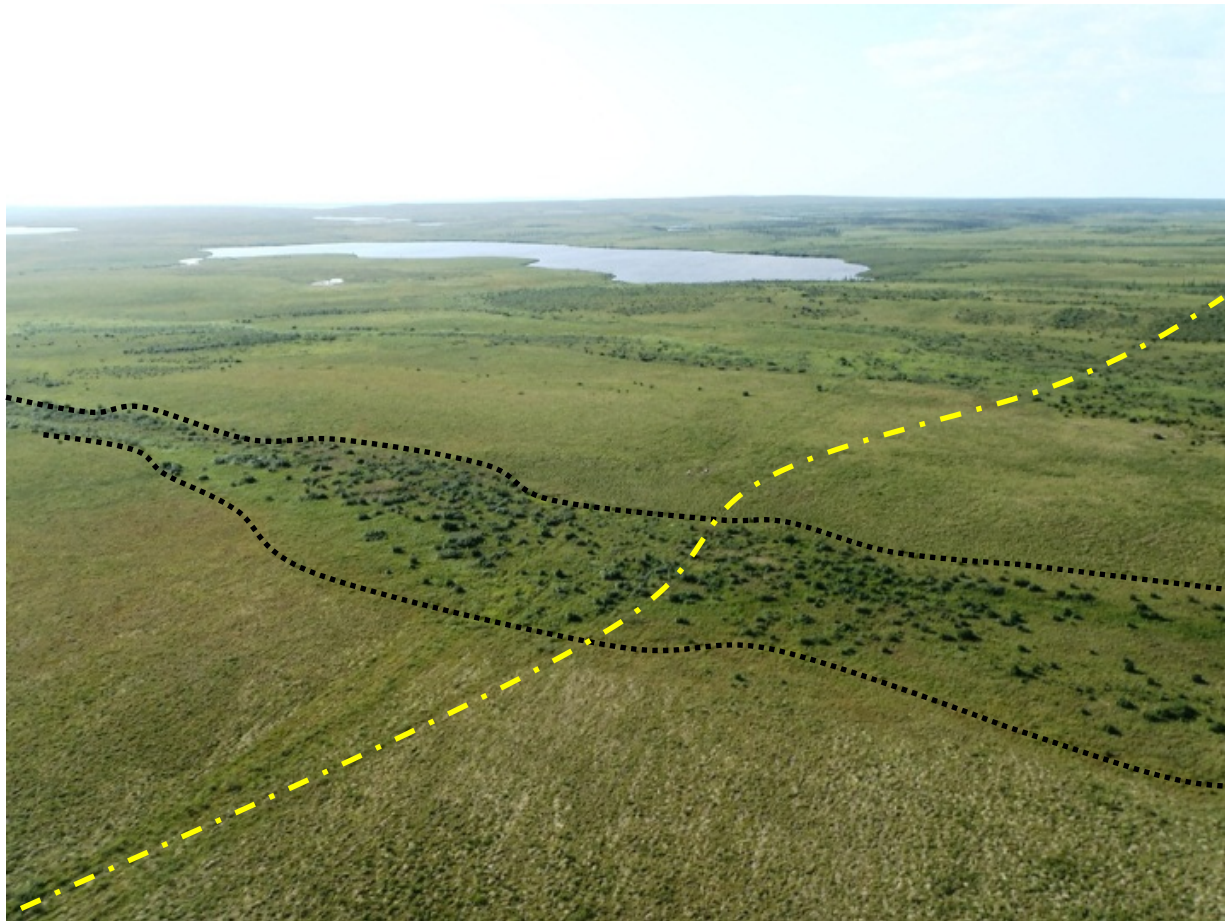
Photo A-6 Gently undulating till topography between KP 23 and KP 25 (route alignment in yellow, drainage channel in black).

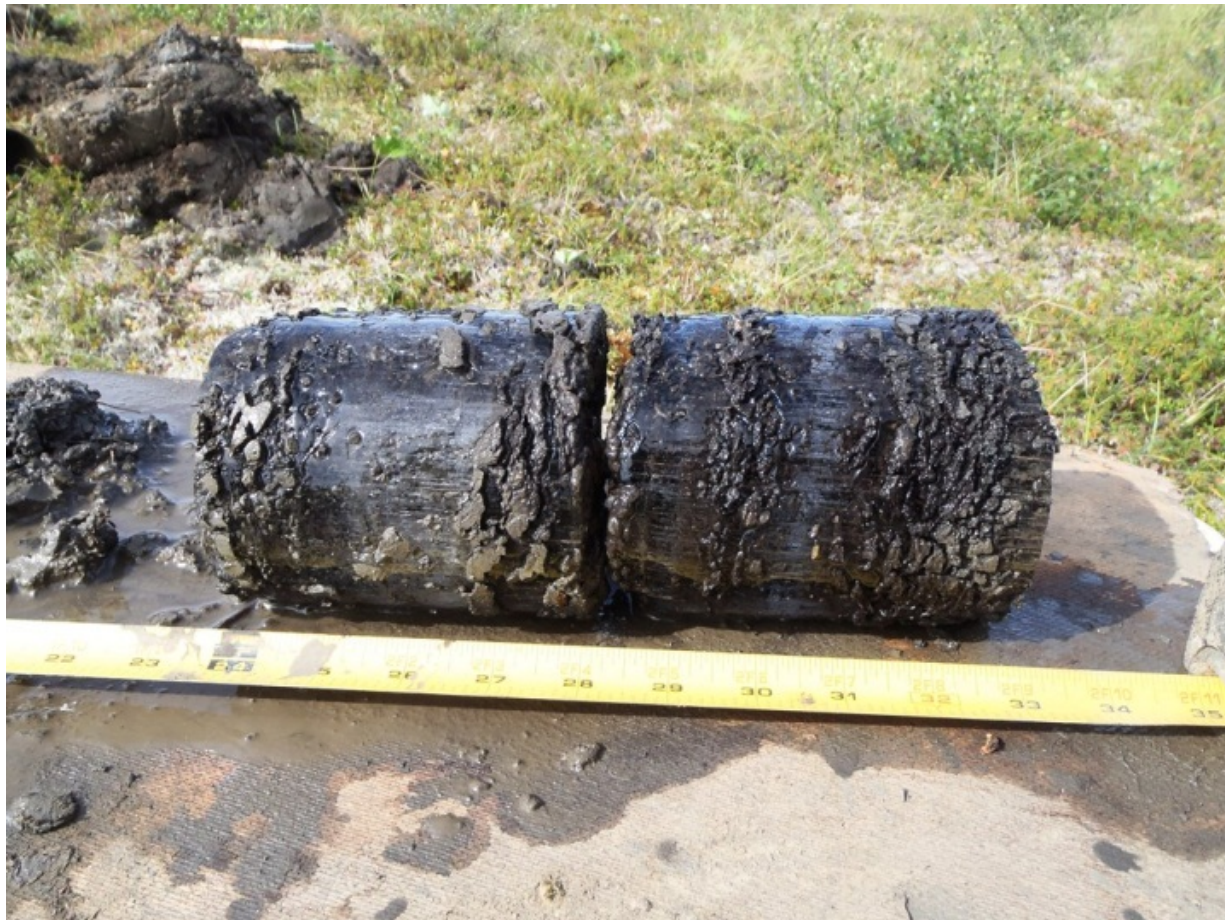
A shallow borehole was drilled in the area separating two of the drainage channels. Sample analysis indicates that the till consist of clayey silt with only a minor fraction of sand and coarse fragments. Ice content in the area immediately below the base of the active layer (i.e. 55cm) was very high, with over 60% ice observed in the samples between 55cm and 1m depth. Visible ice occurred as clear lenses ranging from 3 to 7cm in thickness (Appendix A, Photo A-7).

Photo A-7 Core sample of ice-rich till (>60% ice content) at site GP3 KP23.5.

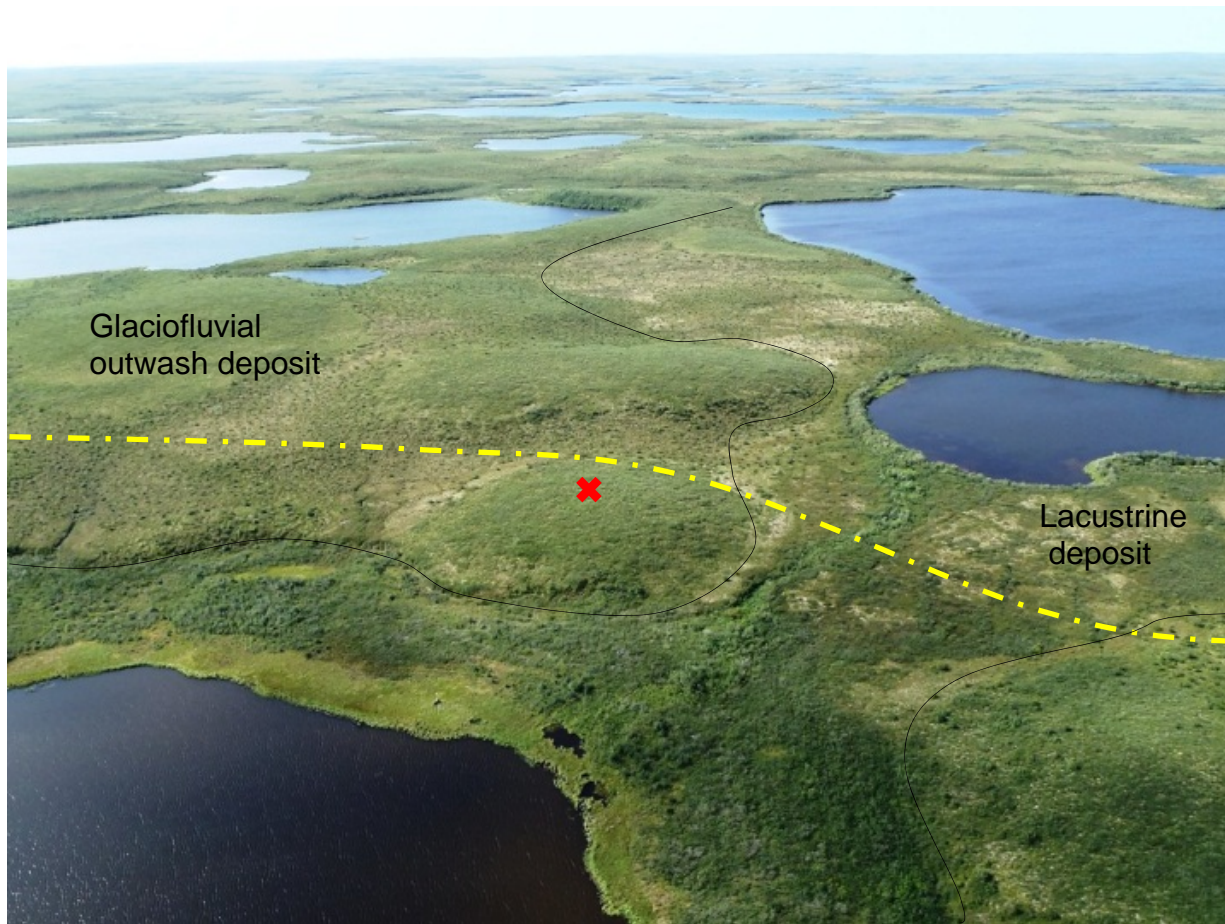
Photo A-8 Oblique view showing the approximate contact between fine grained glaciofluvial outwash and lacustrine deposits (route alignment in yellow, location of the borehole in red)

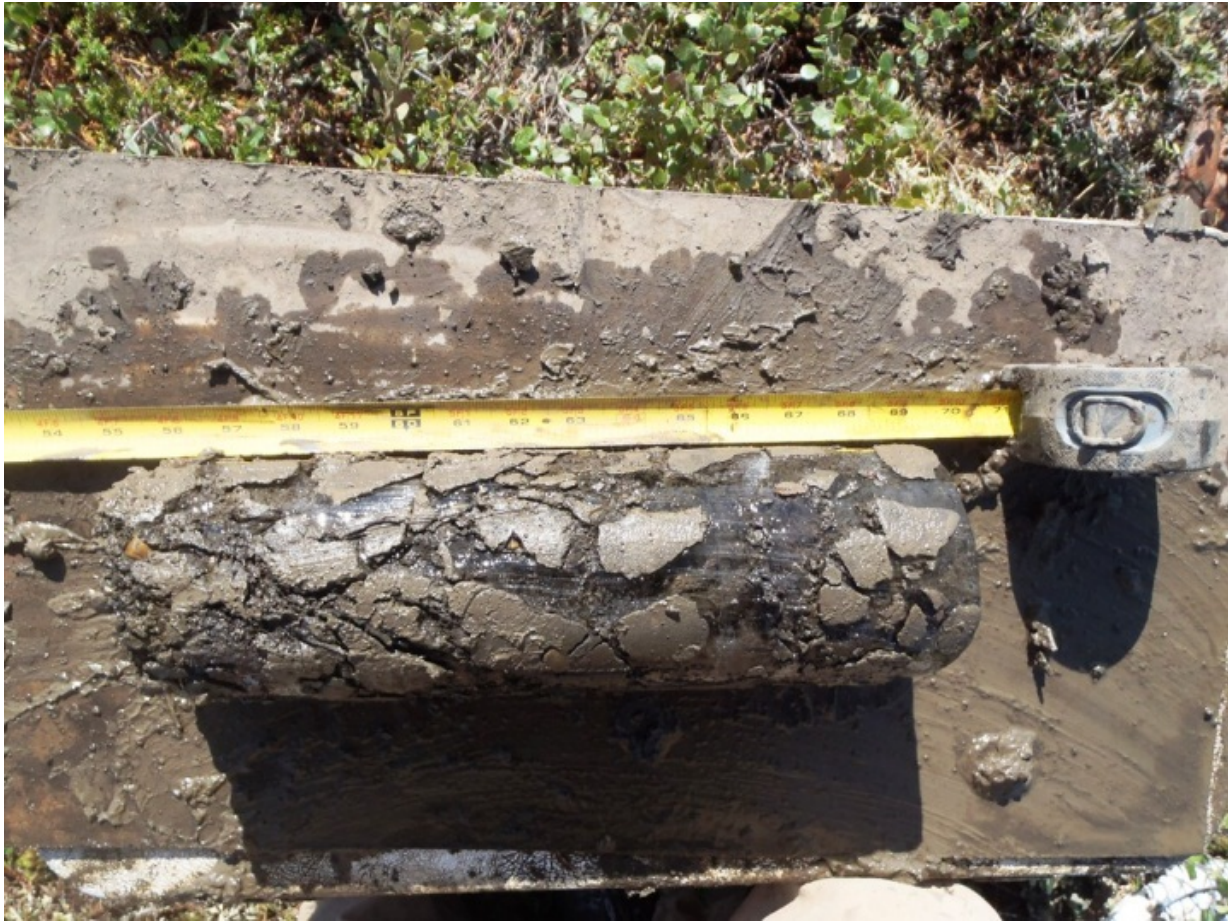
The information collected from a 2 meters deep borehole correlates with the GPR and OhmMapper data. The clayey silt material found at GP5 KP50 is characterized by ice content averaging 50% (Appendix A, Photo A-9) and a sharp contact between clayey silt material and clean sand and gravel was observed at 1.9 meter depth, which correspond to the reflector observed on the GPR profile.

Photo A-9 Core sample from 140cm to 175 cm depth showing random and irregularly arranged ice formations (approx. 50% ice content)

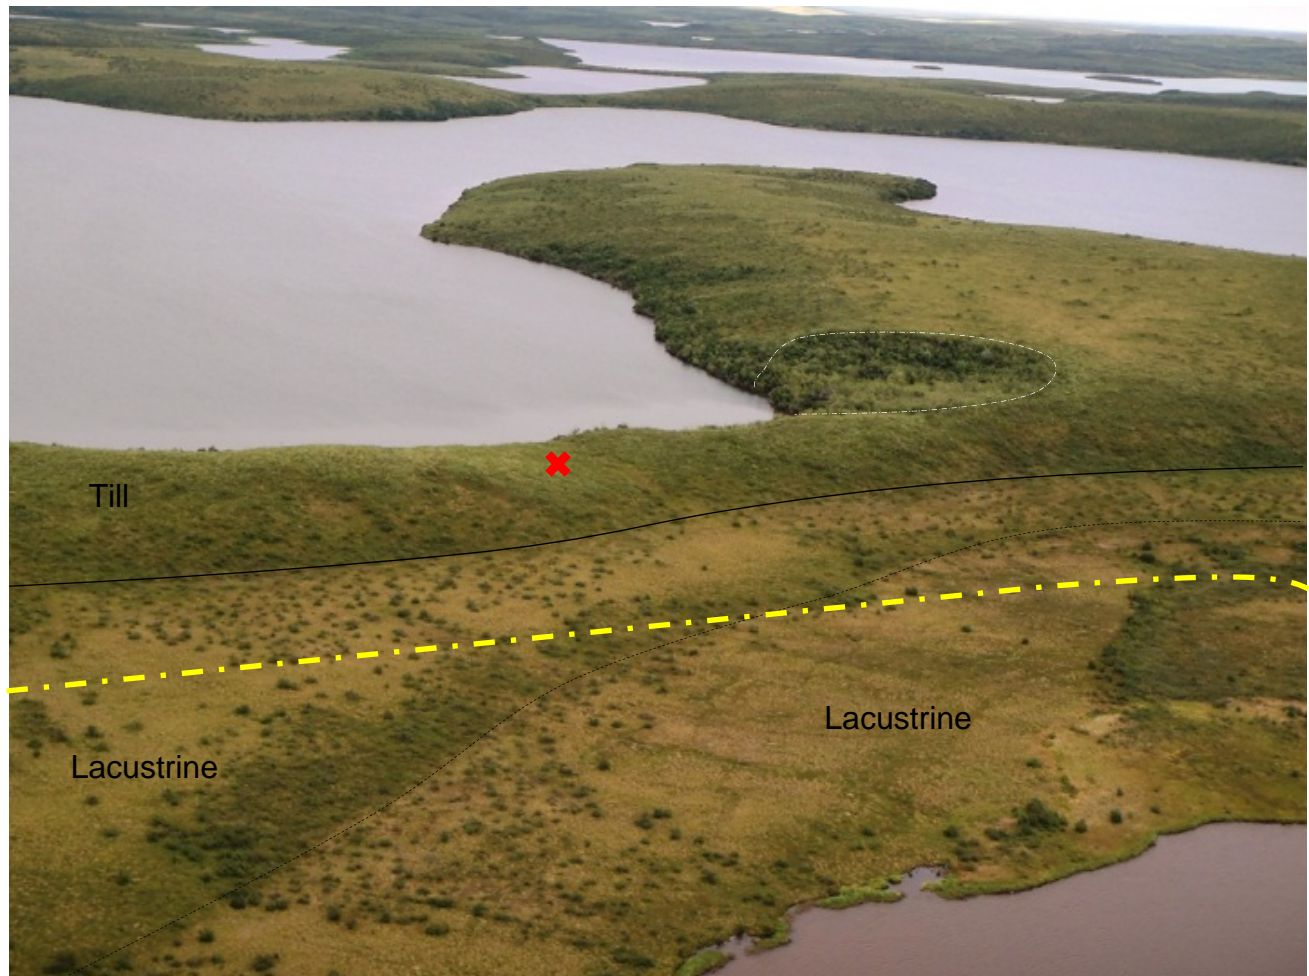
Photo A-10 Oblique aerial view of a till ridge separating two lakes at KP 81 (route alignment in yellow, limit of a retrogressive thaw flow slide in dashed white, contact between till and lacustrine in solid black, previous lake level in dashed black, location of the borehole in red)

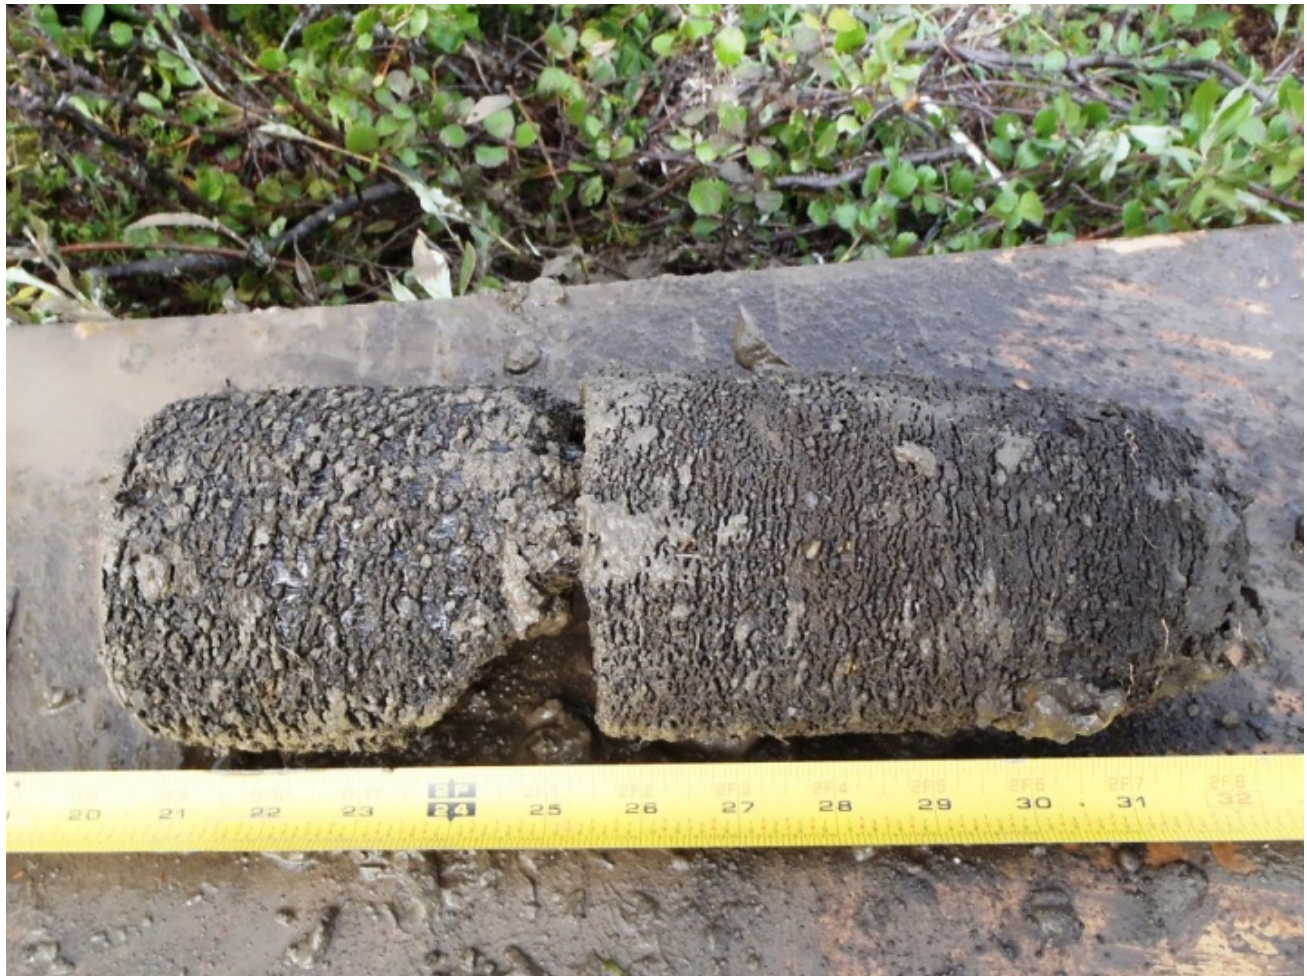
A borehole was drilled on top of the ridge at site GP6 KP81. The core samples indicate that the material in the first meter below ground surface consist dominantly of silt, with minor amounts of clay, sand and gravels. Sand and gravel content increase below one meter depth but silt is still the dominant texture. Active layer measurement average 40 cm on top of the ridge. Ice content was visibly estimated at 70% in the first 10 cm below the active layer. The ice is present as well defined lenses, ranging in thickness from 1mm to 25mm (Appendix A, Photo A-11). Ice content decrease with depth, averaging 15% at 1.3m depth.

Photo A-11 Core sample from 50cm to 80cm depth showing silt with thin (1-3mm) horizontally oriented ice lenses (approx. 30% ice content)

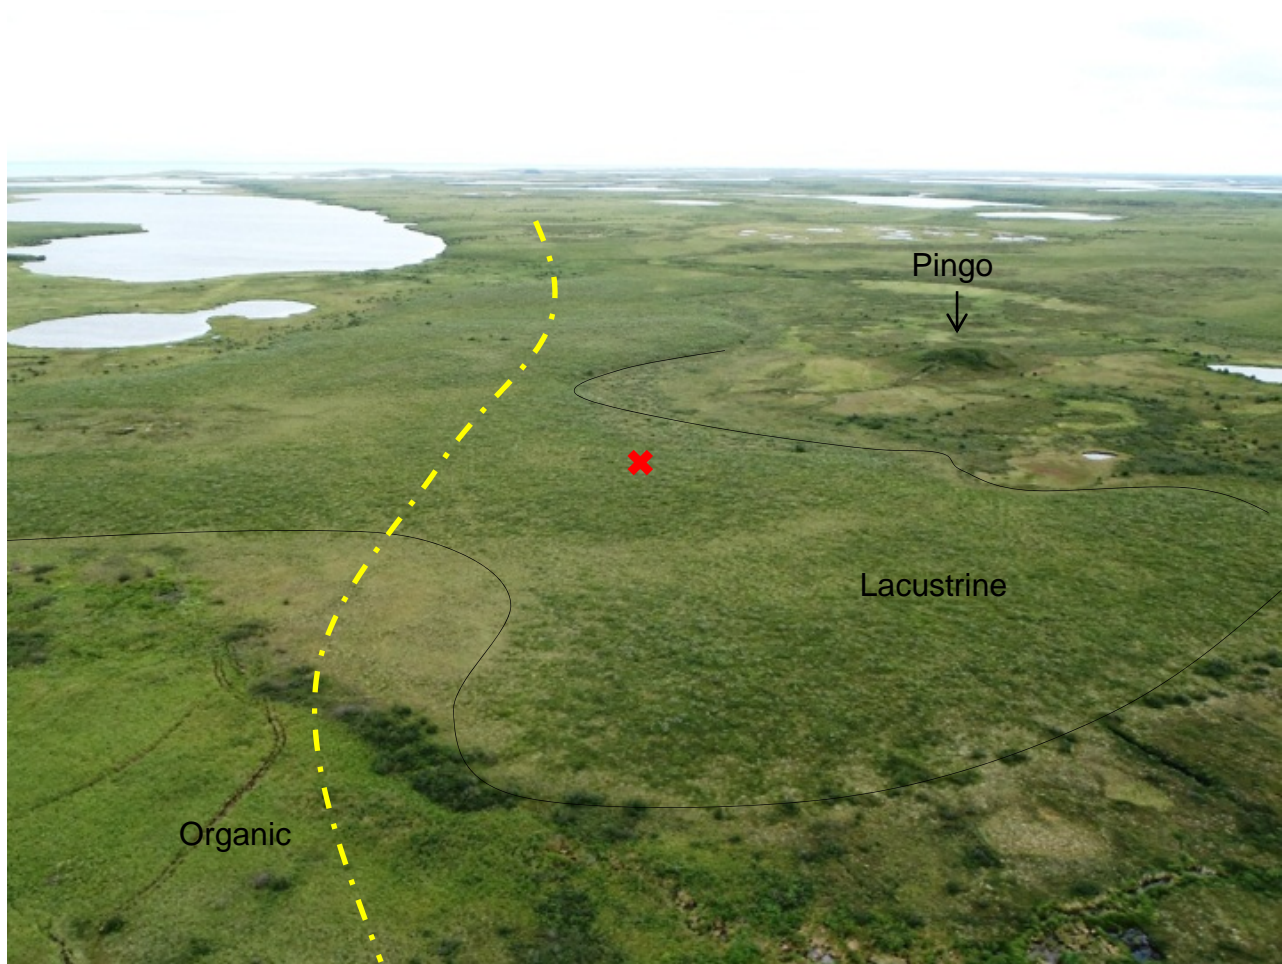
Photo A-12 Oblique aerial view showing a transition from moderately well drained lacustrine deposits to poorly drained organic terrain characterized by ice-wedge polygons (route alignment in yellow, location of the borehole in red)

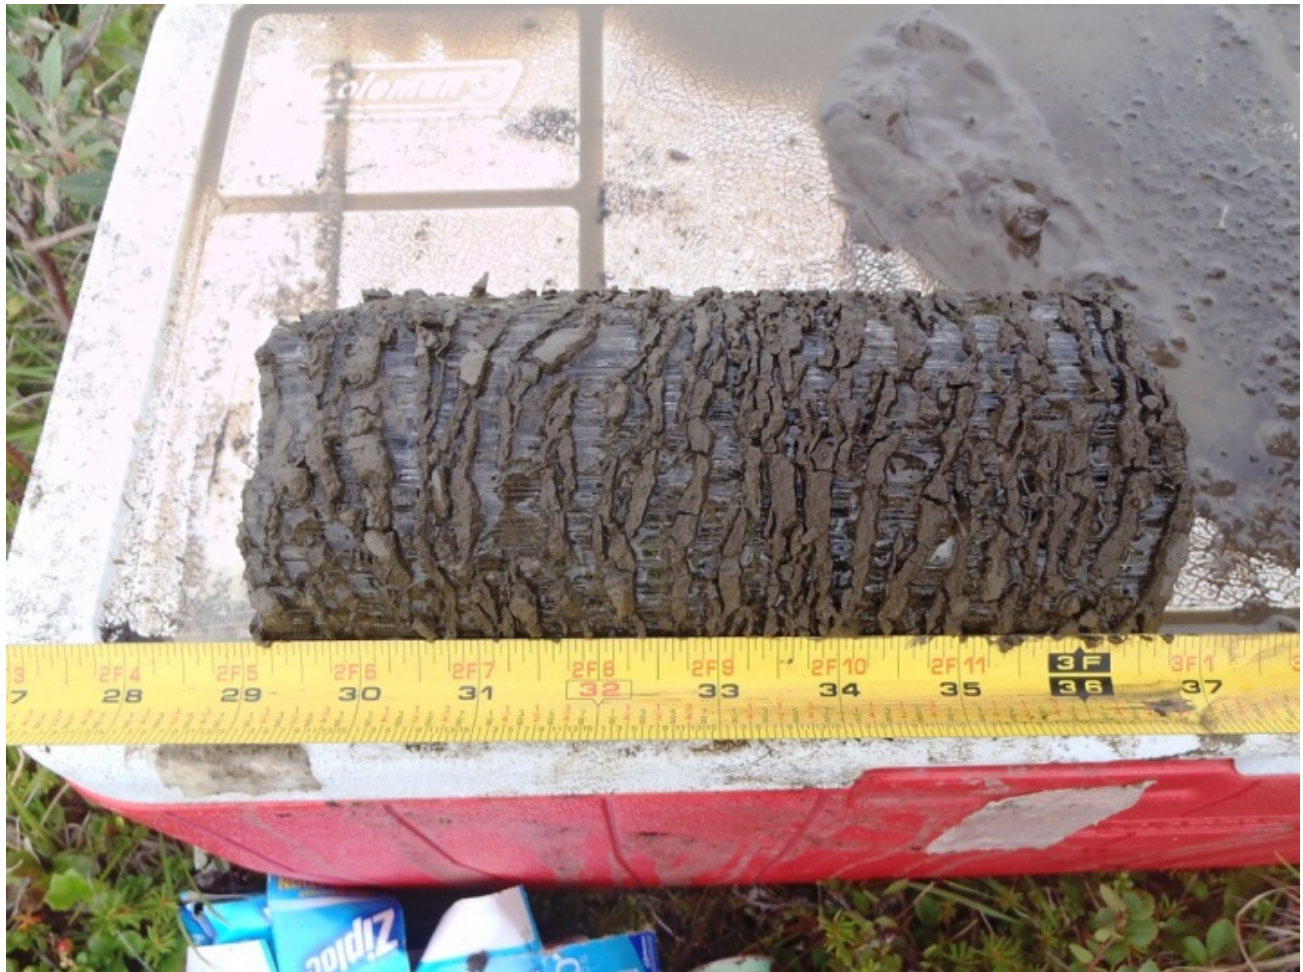
A shallow borehole was drilled away from the ice wedges in the lacustrine material. The borehole showed an active layer of 30cm immediately underlain by a ice-rich layer of peat and silt. Ice content of the material found between 30cm and 1m depth range from 30% to approx. 55% (Appendix A, Photo A-13).

Photo A-13 Core sample from 75cm to 95cm depth showing interbeds of silt and ice lenses (approx. 50% ice content)
