**Inuvik to Tuktoyaktuk Highway –
Terrain and Permafrost Field
Verification Program**

FINAL REPORT

August 31, 2012

KAVIK-STANTEC INC.
Inuvik, NT and Calgary, Alberta

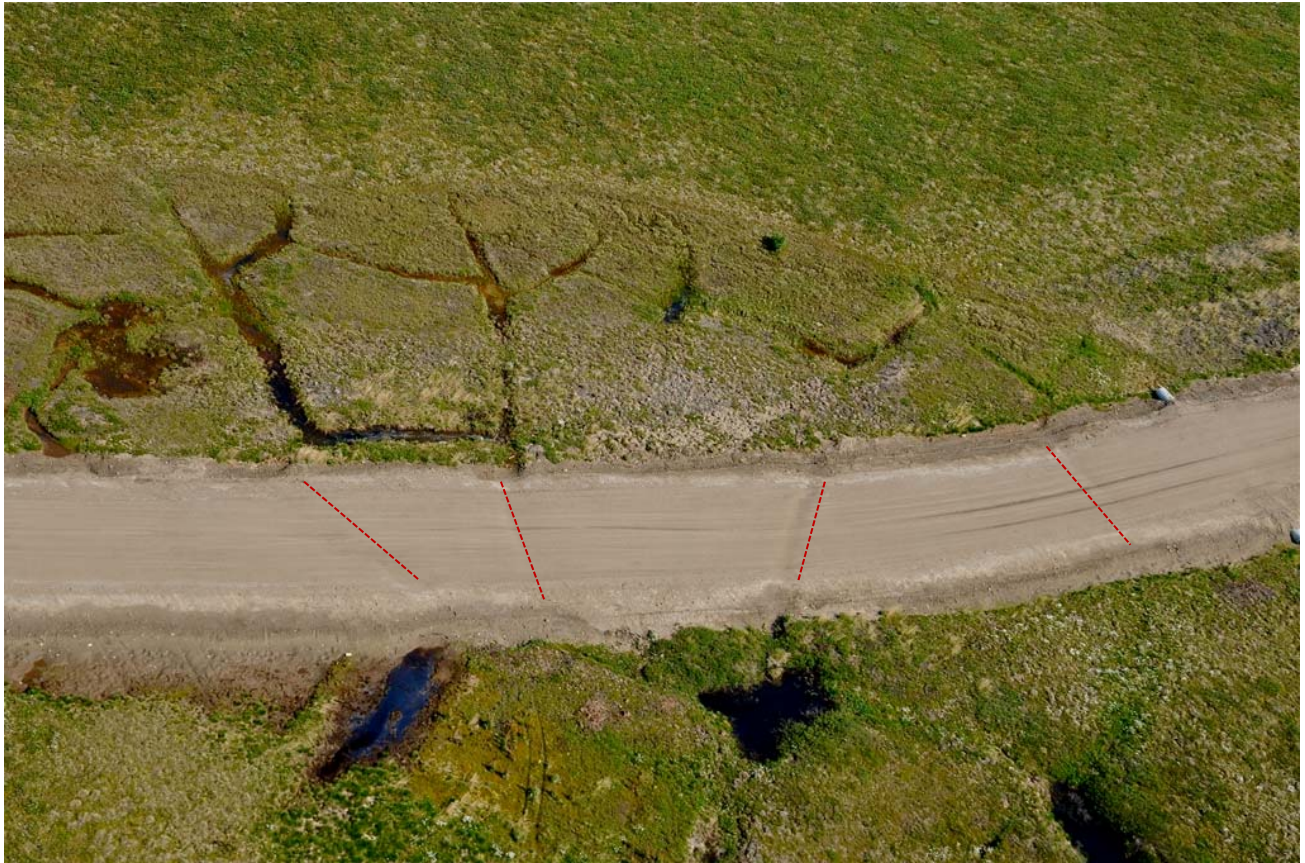
- The most problematic terrain feature found along the alignments is low-lying terrain characterized by ice-wedge polygons. Several areas along the existing access to borrow source 177 show signs of thaw subsidence at the exact location of the ice wedges.

Photo A-14 Oblique aerial view of the access road to gravel source 177 near KP 127 of Alternate 3(thaw subsidence along the red dotted lines)

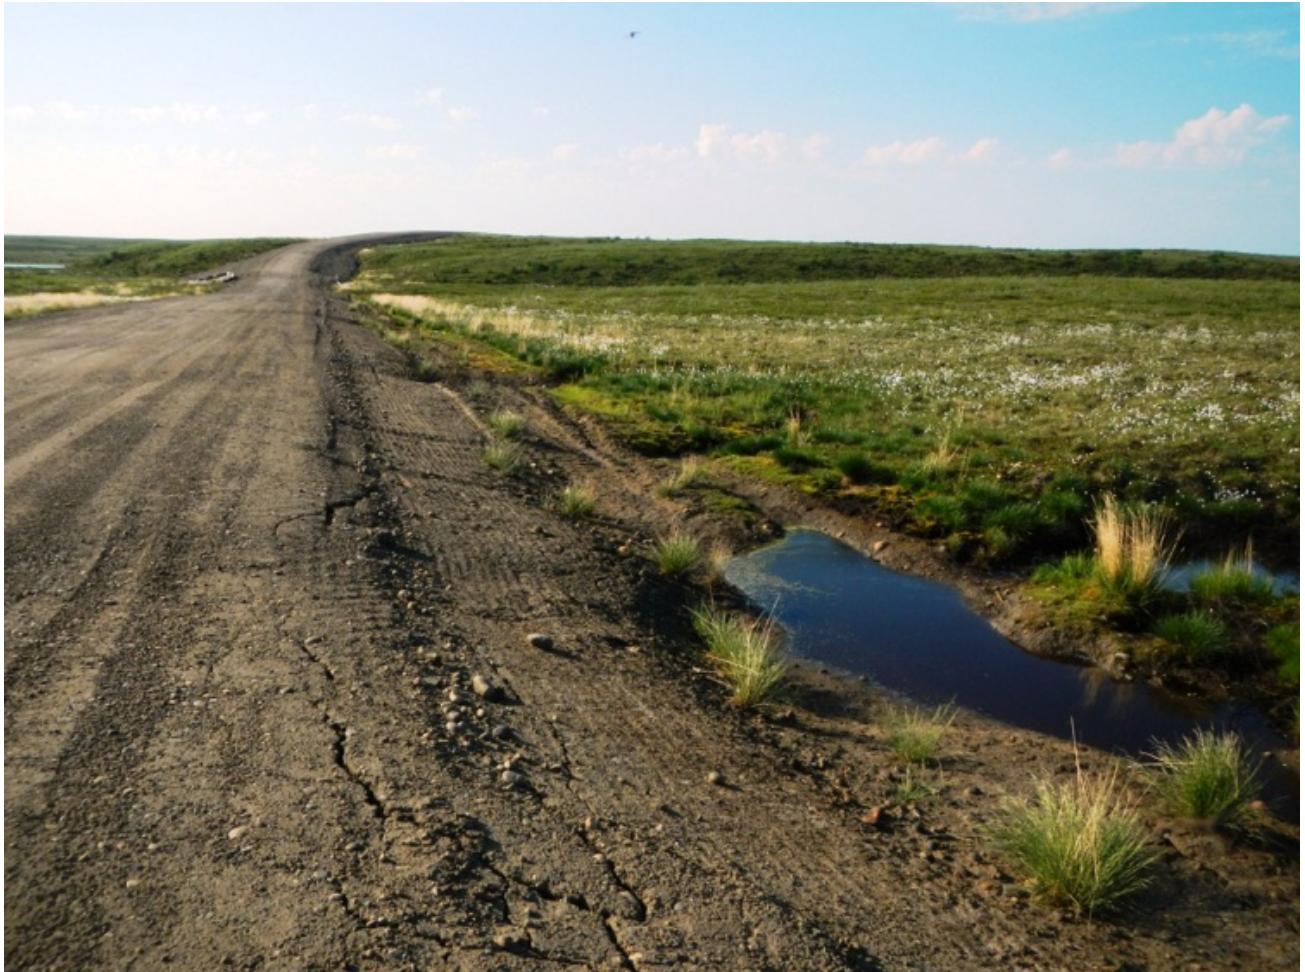
The existing access road to gravel source 177 south of Tuktoyaktuk provided an opportunity to examine a few locations where the embankment was constructed by placing frozen fill directly on a geotextile layer over the surface expression of ice wedge polygons. Aerial and ground examination of sites such as shown in Appendix A, Photo A-14 to A-16, clearly showed subsidence troughs reflecting through the embankment fill. These troughs are an early indication of enhanced thermal erosion where surface water is preferentially using the ice wedge cavities. The hazard this creates for the embankment is the risk of undermining by thermal erosion followed by sudden collapse of the grade. This has been observed at locations on the Dempster Highway and Alaska Highway (Transportation Association of Canada 2010) and has been known to cause at least one fatality. The application of terrain analyses can identify hazard locations such as the polygon fields in a timely manner for feedback to the engineering design.

Photo A-15 Thaw subsidence, tension cracks and ponding of surface water along the road bank of the access road to gravel source 177

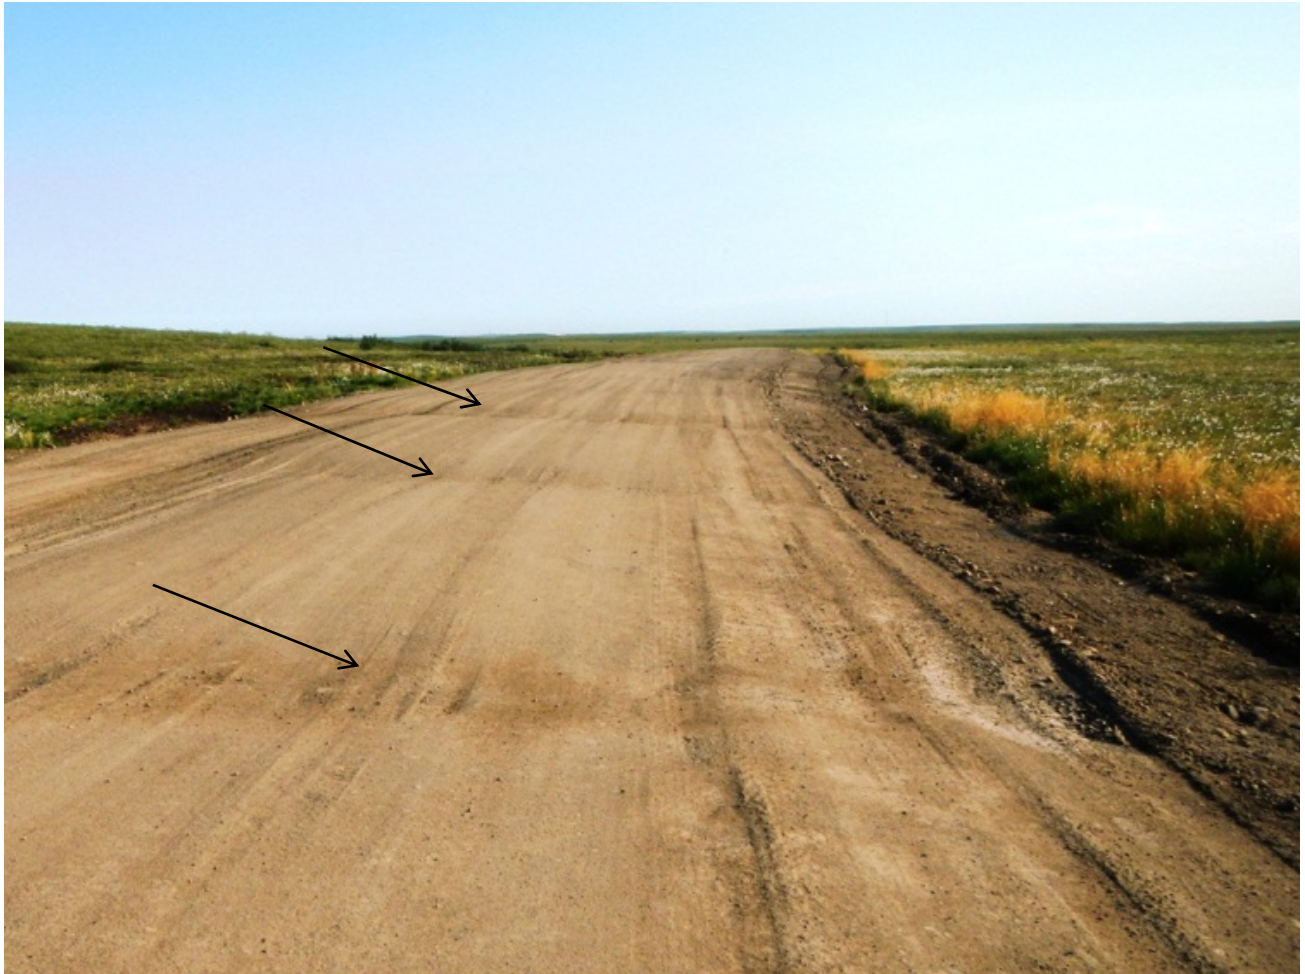
Photo A-16 Thaw subsidence showing the location of ice wedges under the road bed (black arrows).
