Terrain Assessment of the
Proposed Inuvik to Tuktoyaktuk Highway

October 2010

Prepared for: North Mackenzie District

Prepared by: Terrain Sciences Unit

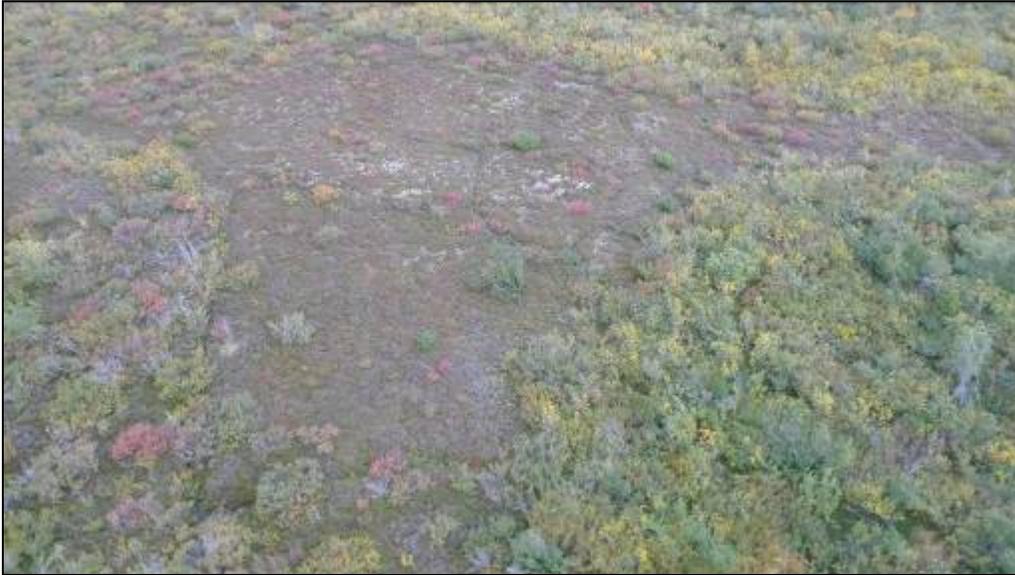
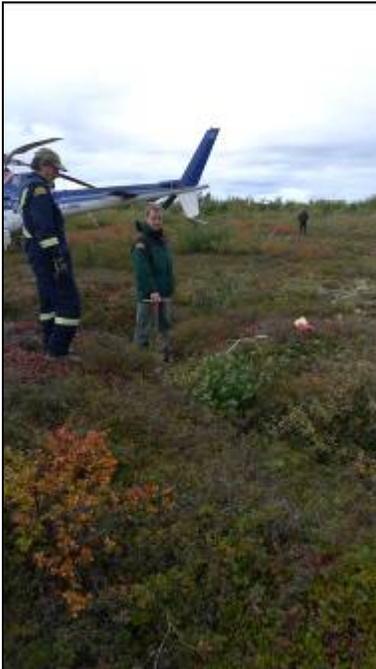
Site 75: 68°30'39"N 133°46'33"W

A small (60 x 50 m) area of polygonal terrain surrounded by tall shrubs was observed in the southern portion of the route (Figures 2&3). The ice wedges were located in an

organic peatland with low shrub and herb vegetation. At the surface, the ice wedge troughs were approximately 1.5 m wide and 0.5 m deep.

Figure 2 Site 75, a small polygonal peatland surrounded by tall shrub terrain.

Figure 3 Site 75. Note the relief between polygon troughs and centres.

In this terrain, polygonal peatlands are widely spaced and can likely be avoided. However, polygonal areas should be identified prior to construction as they would be difficult to identify when snow-covered during the winter construction season.

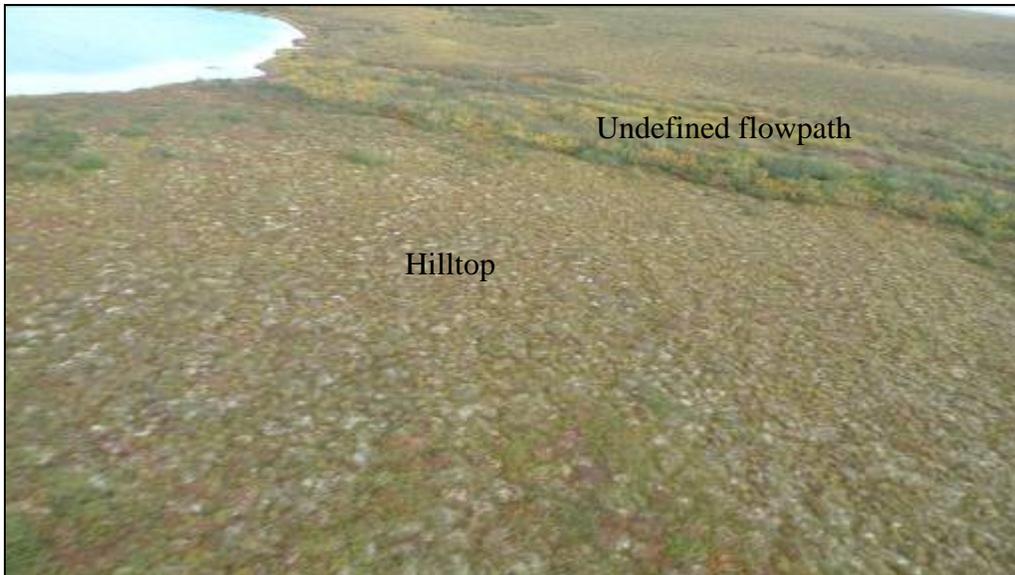
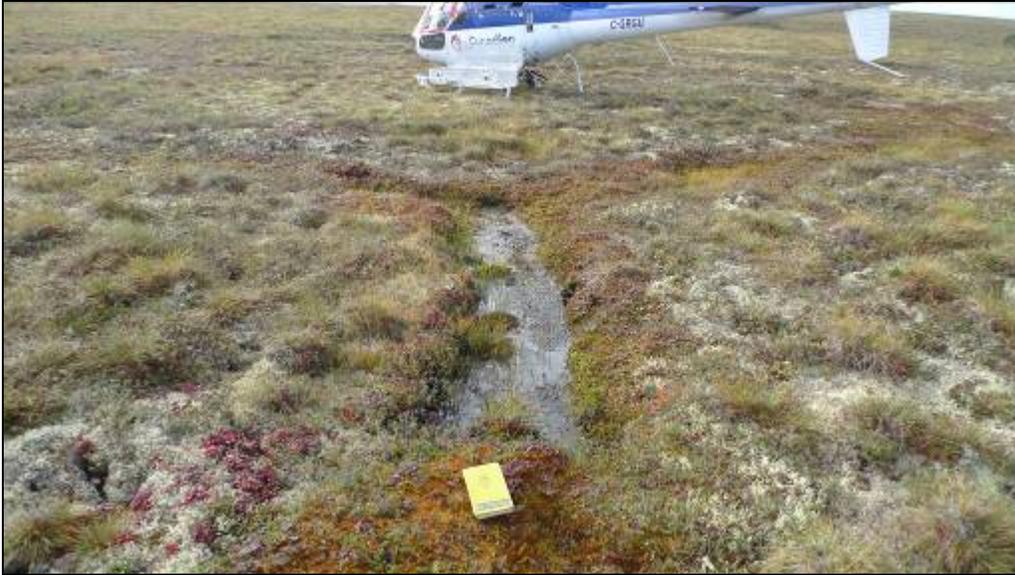
Site 84: 68°35'57"N 133°41'07"W

Several terrain conditions that could complicate highway construction were observed at this site. A small polygonal peatland was situated on a hilltop bounded on one side by a low polygonal area and on the other by a wide, undefined drainage (Figures 4&5). The small polygonal area on the hilltop was difficult to identify by aerial photograph or flyover. The difficulty in identifying this area emphasizes the importance of examining much of the proposed route on the ground prior to construction.

The wide, undefined drainage is typical of many non-channelized flowpaths that the highway will likely cross. These flowpaths may pose a hazard to the highway due to the warming influence of flowing water. Non-channelized flow is difficult to capture in a culvert. Drains designed to allow water to flow under the highway may transfer heat to the road base and cause subsidence. If the area remains undrained, the highway could act as a dam, resulting in ponding against the highway leading to warming and subsidence of the area. Highway planning will require consideration of how these non-channelized flowpaths will be crossed with minimal disturbance to the highway and surrounding terrain.

Figure 4 Site 84, Hilltop with a polygonal peatland in the foreground, and an undefined flowpath in the background.

Figure 5 Site 84. An ice wedge trough on the hilltop that was difficult to identify from the air.

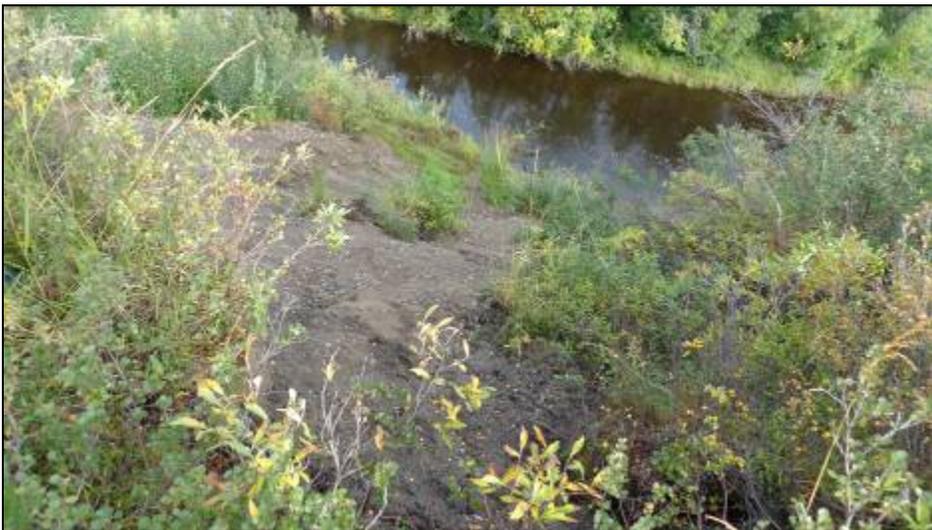
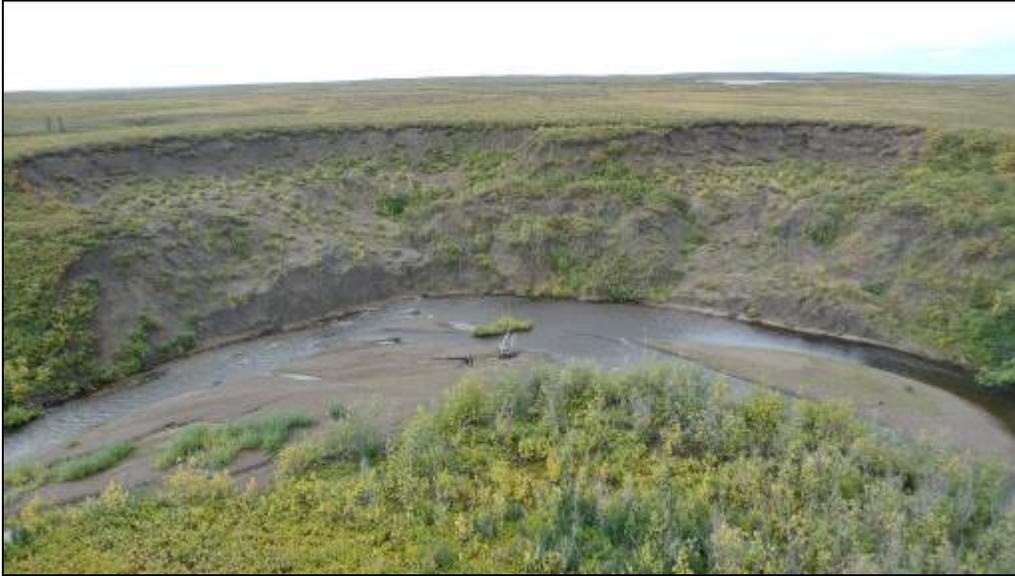
Hans Creek: 68°52'04"N 133°33'35"W

Three slumps were observed on the south bank of Hans Creek, adjacent to the proposed route. One 12-m wide slump was likely active since blocks of the fallen active layer covered with live vegetation were situated in the creek below (Figure 6). The exposed sediments at the active slump were gravels and sands with no visible ice content. Two older, revegetated slumps were located immediately east of the active slump, and were each approximately 20-m wide. A large, active slump was located approximately 2 km downstream from the other slumps (Figure 7). All of the slumps were located on steep banks or cutbank slopes. Route planning should account for active and non-active slumps and slump-prone areas along streams and ensure that the highway is located at a safe distance away from them.

Figure 6 Small, active slump next to proposed highway crossing of Hans Creek.

Figure 7 Large, active slump on a cutbank downstream of the proposed crossing of Hans Creek.

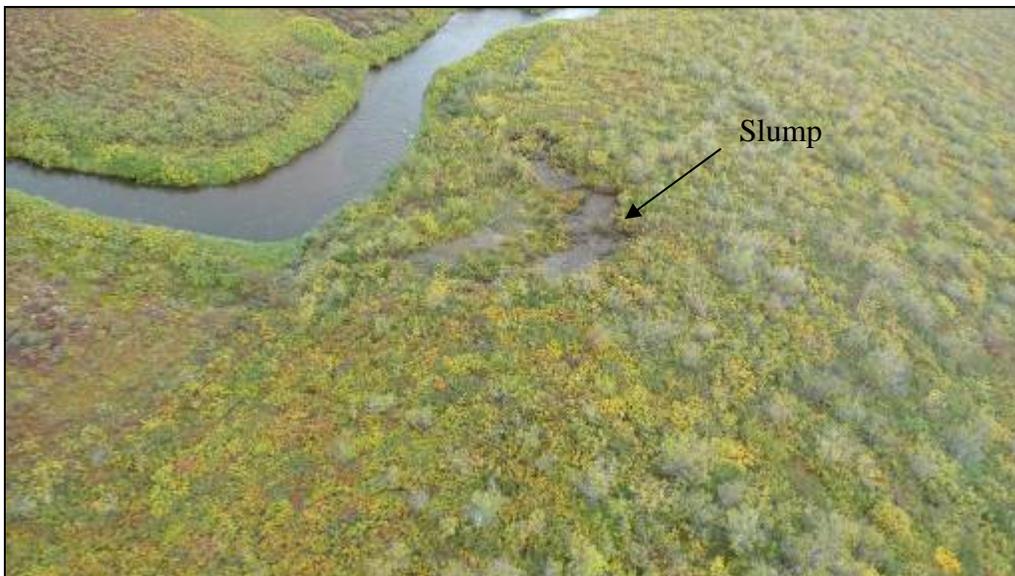
Zed Creek: 68°56'24"N 133°25'02"W

Zed Creek has significantly lower banks than Hans Creek; however, even in the gentler terrain, a recently active 25-m wide slump was observed on a cutbank downstream of the proposed highway crossing at Zed Creek (Figure 8). There was no visible ice in the clay and silt sediments. Route planning should account for active and non-active slumps and slump-prone areas even along streams with low banks.

Figure 8 Small, active slump on a cutbank of Zed Creek, downstream of the proposed highway crossing.

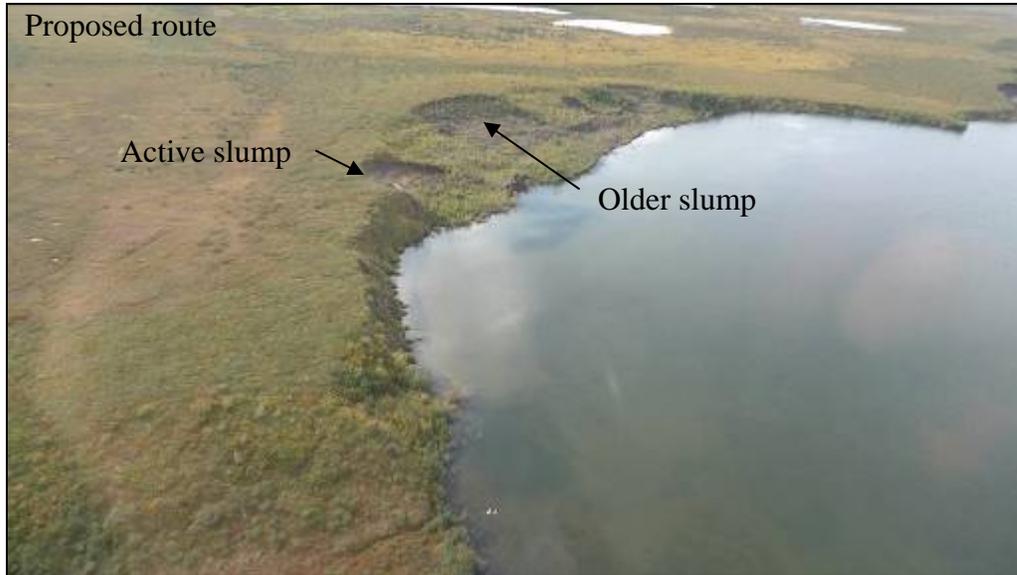
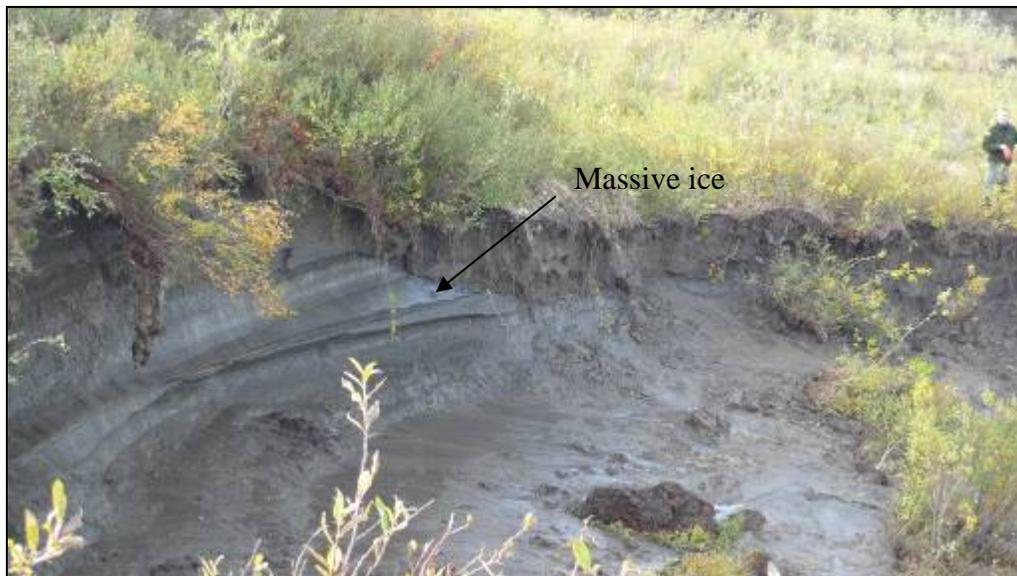
IT Highway Slumps: 69°05'11.5"N 133°03'23.5"W

Two active lake-shore slumps and two older, revegetated slumps were observed on the south shore of a lake approximately 150 m north of the proposed highway (Figure 9). Massive ice was observed at the base of the headwall in the active slumps (Figure 10). Thaw slumps retreat backwards as ground ice in the headwall melts. New thaw slumps tend to form adjacent to old, revegetated thaw slumps. Active slumps, their rate of growth and older thaw slumps should be considered when routing the highway.

Figure 9 Active and revegetated slumps on a lake-shore next to the proposed route.

Figure 10 Detail of massive ice in the headwall of one of the active thaw slumps.

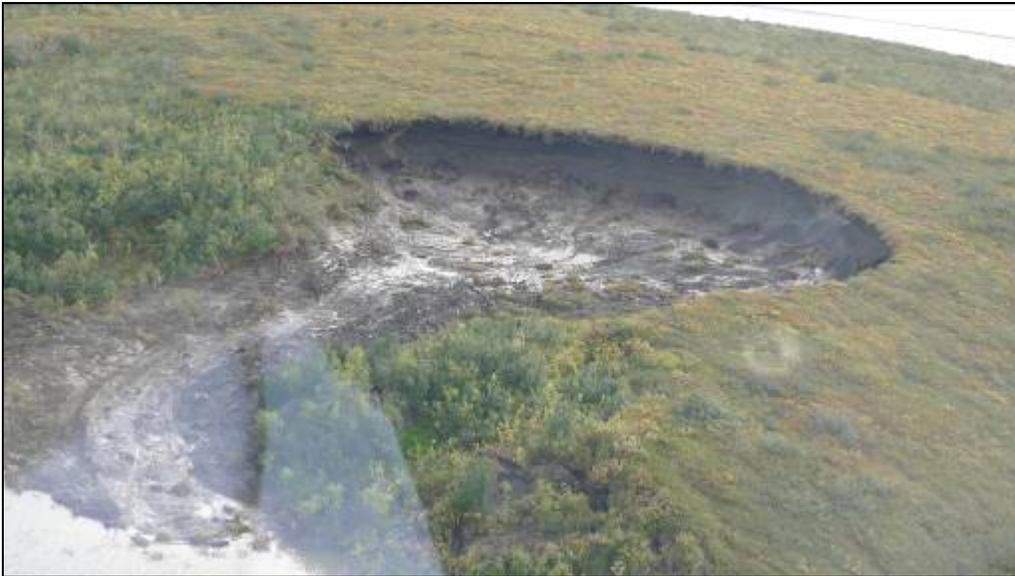
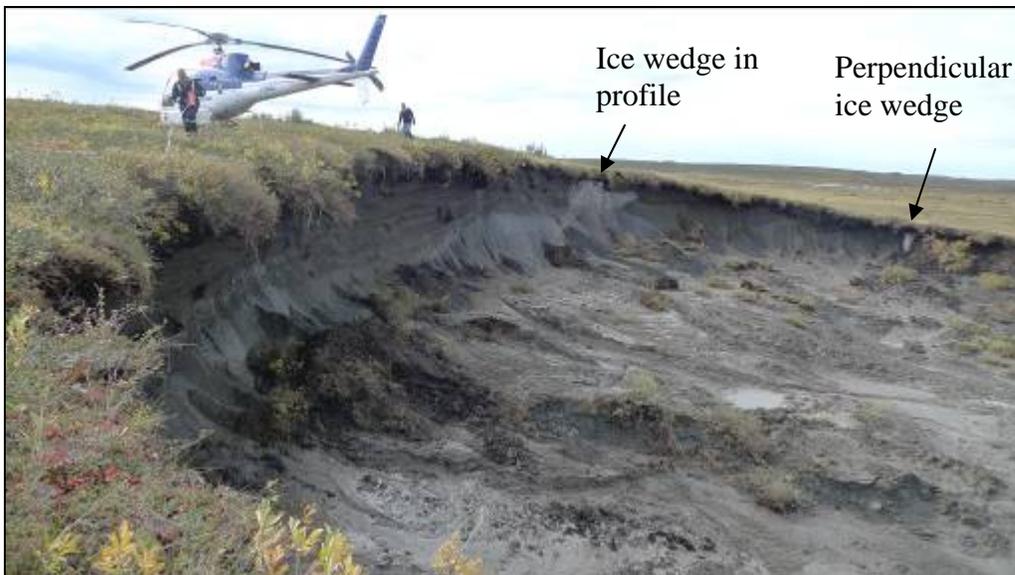
Husky Lake Slump: 69°07'49.7"N 132°55'03.4"W

A slump approximately 2 km from the proposed highway was observed to record its configuration and examine ground ice conditions in the slump headwall (Figure 11). The headwall was approximately 83-m long and 6-m tall. Three ice wedges were exposed by the headwall, ranging from 1 to 4 m width at the top of permafrost, and tapering to about 1.5 to 3 m at the base of the headwall (Figure 12). The largest ice wedge exposure was seen in profile, but the other two ice wedges were situated perpendicular to the headwall.

Figure 11 Thaw slump near Husky Lakes. Note that it initiated in previously slumped terrain, as indicated by the tall shrub vegetation.

Figure 12 Ice wedge exposures in the headwall of a slump near Husky Lakes.

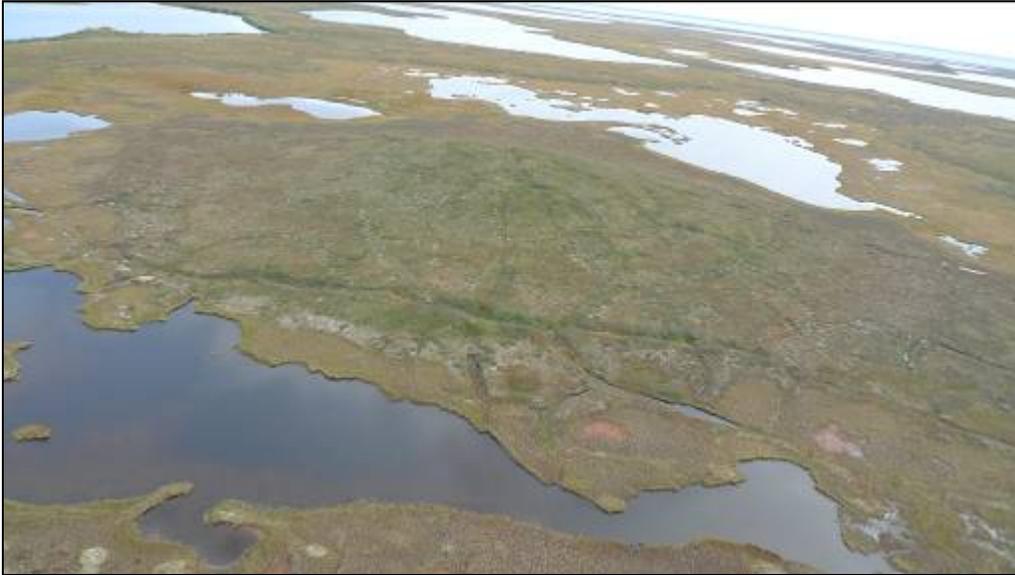
IT Highway Pingo: 69°14'13.4"N 132°53'55.2"W,
IT Highway Pingo 2: 69°09'04.7"N 132°55'40.4"W

Two pingos were observed in close proximity to planned highway route (Figure 13). Pingos are thaw sensitive due to a solid ice core. Pingos are often explicitly protected by land use permit conditions that state that no land use operation can be conducted within 150 m of a pingo. Route planning should ensure that pingos are avoided.

Figure 13 Pingo located near the proposed route.

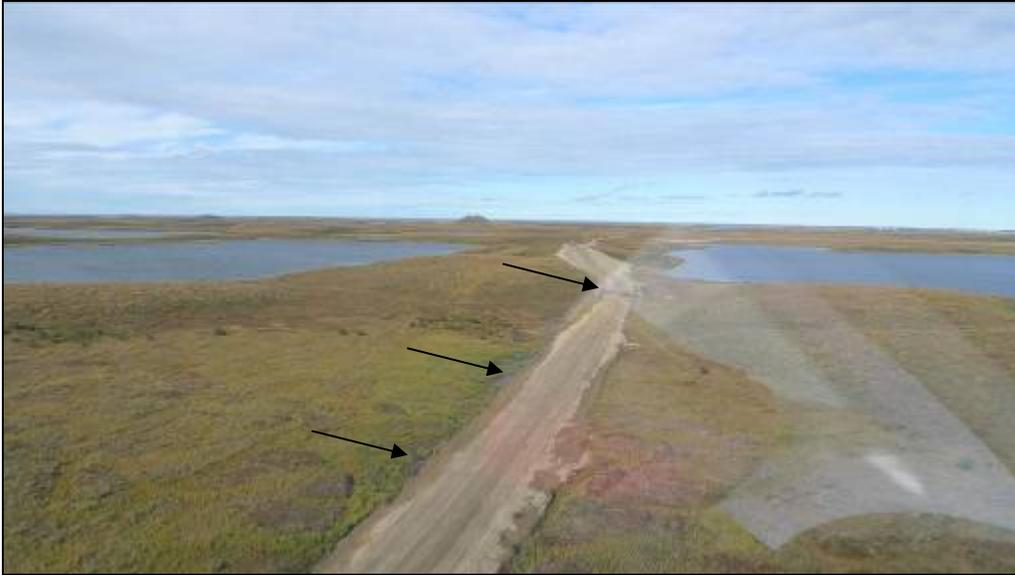
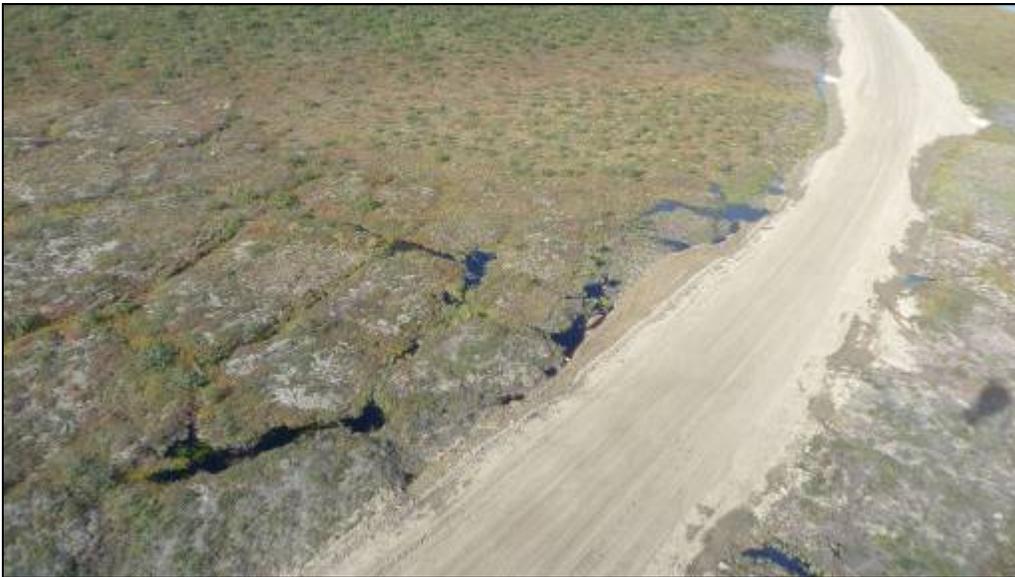
Standing water was observed to be ponding next to the road in multiple locations (Figure 14). Ponded water is a source of heat that can degrade permafrost and cause subsidence of the highway and the adjacent terrain. For example, ponded water may lead to the enlargement of ice wedge troughs next to the road and the melting of ice wedges under the road (Figure 15). At a site next to the road, ice wedge trough widths were approximately 1-2 m and active layers were thicker than at a site located 50 m away from the road where troughs were about 0.5-m wide.

Figure 14 Multiple areas of water ponded against the Source 177 road.

Figure 15 Ponding of water and enlargement of ice-wedge troughs next to the Source 177 road.

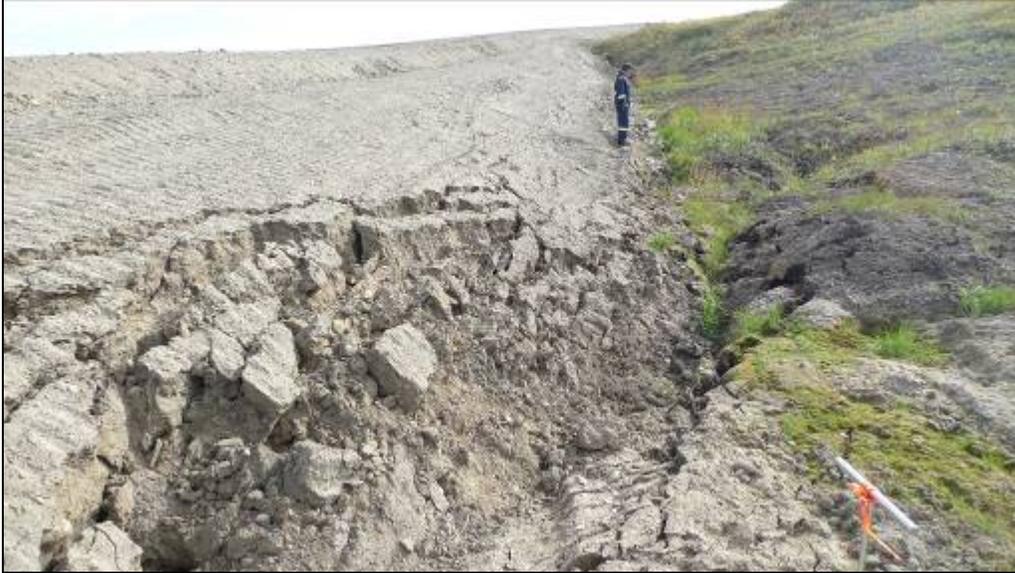
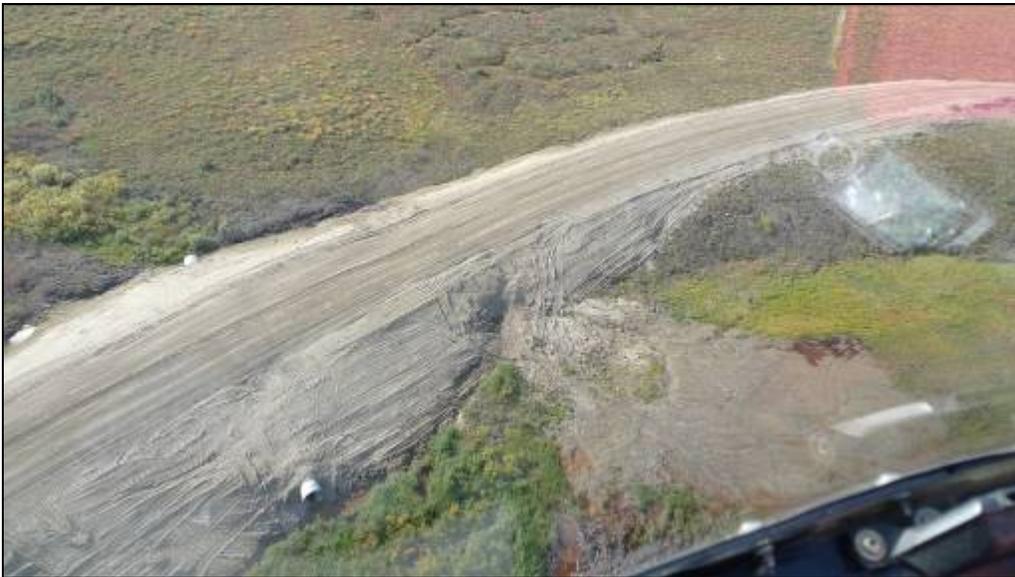
Slumping of embankment materials was observed at several sites along the road (Figures 16&17). The slumping could be due to the use of fine-grained materials to construct the embankments or the melting of ice within the road materials. Ground ice within granular materials should be allowed to melt and drain prior to their use in highway construction.

Figure 16 Slumping of Source 177 road embankment material.

Figure 17 Another area of embankment material slumping and flowing across the tundra.
