**Inuvik to Tuktoyaktuk Highway -
Baseline Data Acquisition Program
Terrain Evaluation**

Final Report

Prepared for:
**Government of the Northwest
Territories – Department of
Transportation**
Yellowknife, NT

Prepared by:
KAVIK-STANTEC INC.

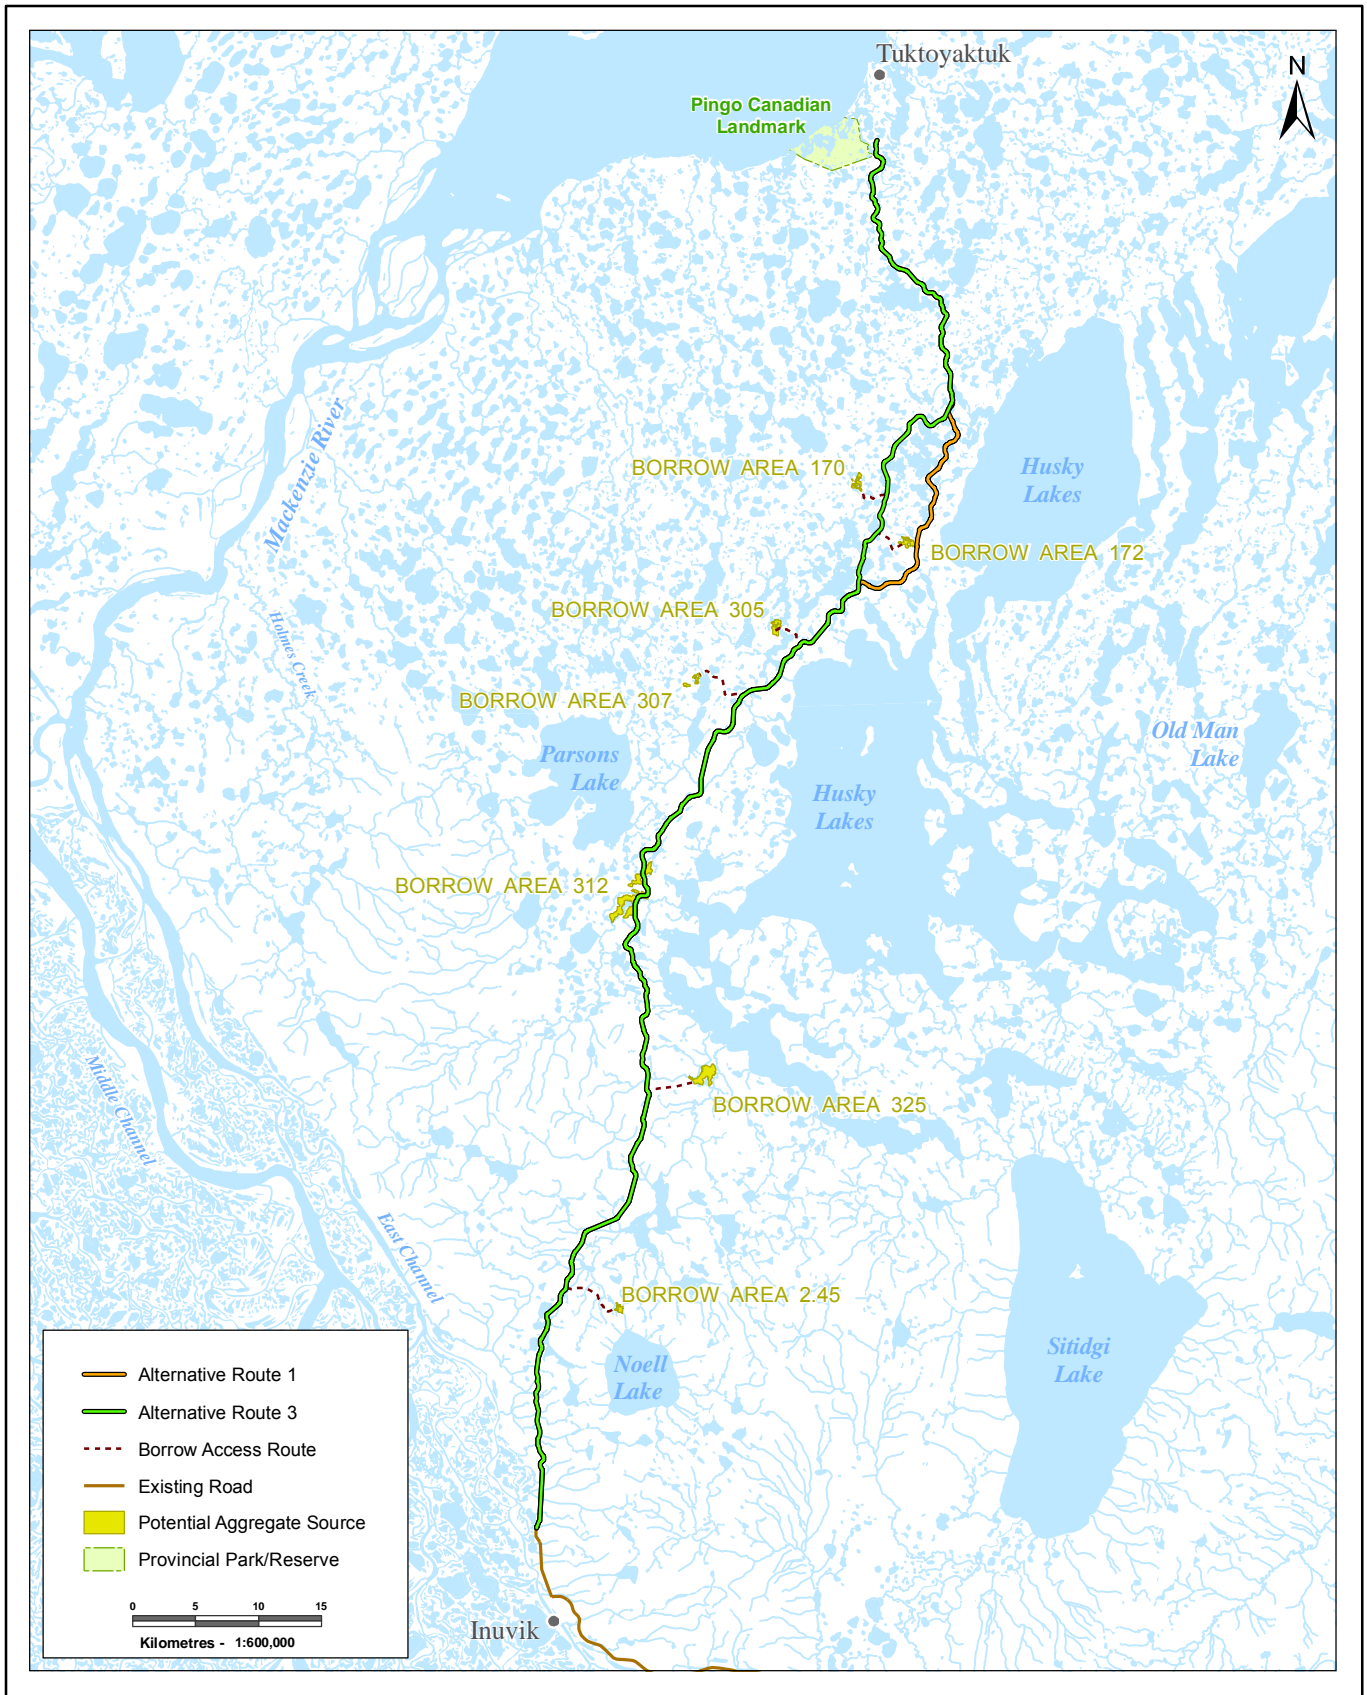
Proposed Highway Alignments, Borrow Sources and Access Roads

- **Alternative 1** – The 2009 Minor Realignment of the Primary 2009 Route to fully achieve the Husky Lakes 1 km setback requirements; and
- **Alternative 3** – the 2010 Minor Realignment, recommended by Inuvialuit interests to modify Alternative 1 and to provide a more direct route.

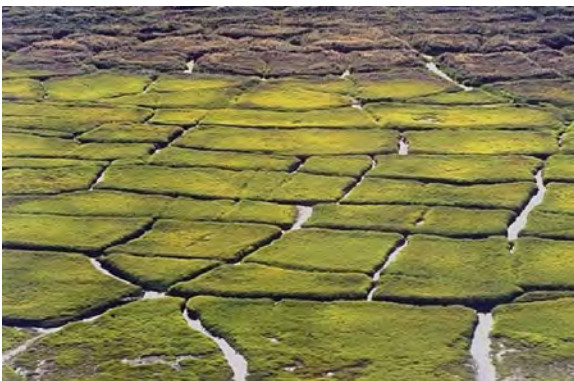
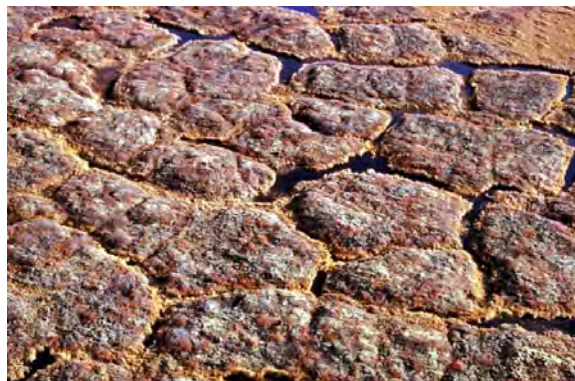
Figure 3-2 Low-centered polygons and high-centered polygons (photos from Geological Survey of Canada)

Ice wedge polygons are a type of patterned ground that is found primarily in low-lying, moderate to poorly-drained areas. They are the result of thermal contraction and cracking of the ground surface which then forms a random or oriented polygonal pattern (ACGR 1988). The cracks that result from the thermal cracking fill with seepage water that comes primarily from the melting of snow and the water refreezes during winter as ice veins. As frost cracking reoccurs in pre-existing cracks, the accretion of ice veins with time builds up ice wedges (Fortier and Allard 2004). The volume of ice contained in tundra polygons is extensive and probably represents the most widespread and abundant form of ground ice (Washburn 1979; Harry and Gotzik 1988; Kasper and Allard 2001). Ice-wedge polygons occur in both mineral terrain and peatlands. They can be classified as low-centered and high-centered (Figure 3-2 as well as photo A-3 and A-4 of Appendix A); the contrast between the two types may be partially due to the age of the features as well as the local hydrology (Rampton 1988). Over time, low-centered polygons can evolve into high-centered polygons.

Polygons found along the alignment range considerably in size but are typically 15 to 30 m in width. They are found extensively throughout the project, but especially in low-lying areas such as peatlands, drained lake bottoms and former meltwater channels. Both proposed alignments cross several large polygonal peatlands characterized by poor drainage.

Recent degradation of some ice wedge polygons has been identified during the air photo interpretation exercise (e.g. KP 54.5, KP 83). The degradation process is generally due to thermo-erosion of the ground ice by the melting-acting of flowing water, which can further lead to rapid lake drainage (Fortier et al. 2007; Mackay 1974, 1981a, 1988a). The melting leads to the development of a gully system (or trenches) which can drastically rearrange the local topography and drainage pattern (Fortier et al. 2007).

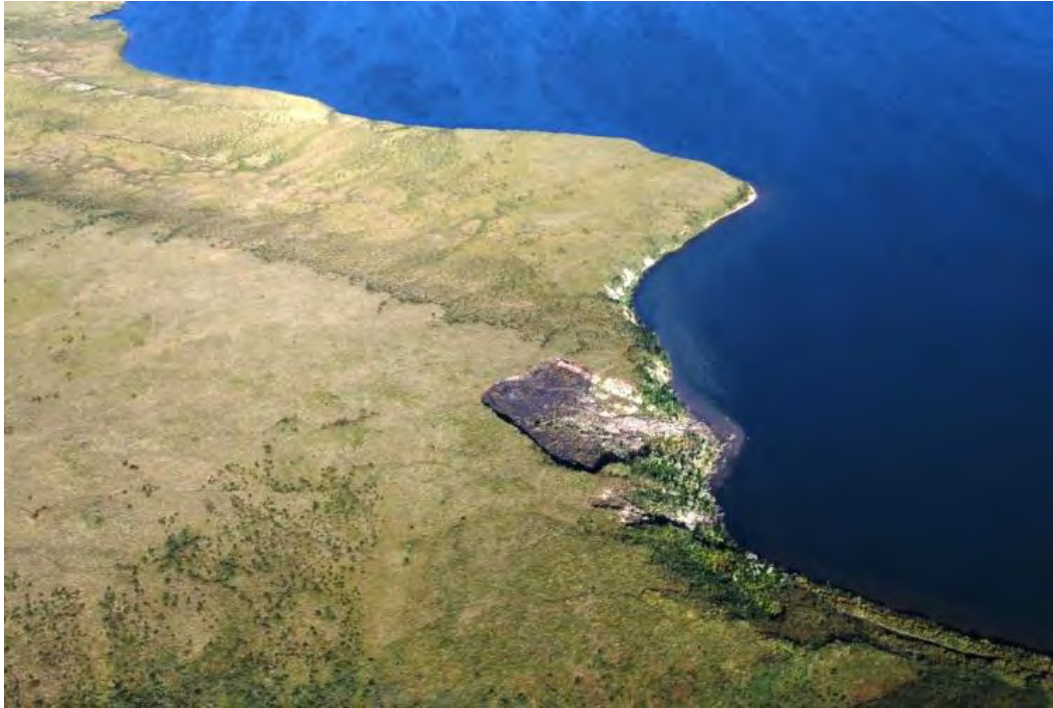
Photo A-1 Retrogressive thaw slumps near KP 93 of Alternative 1

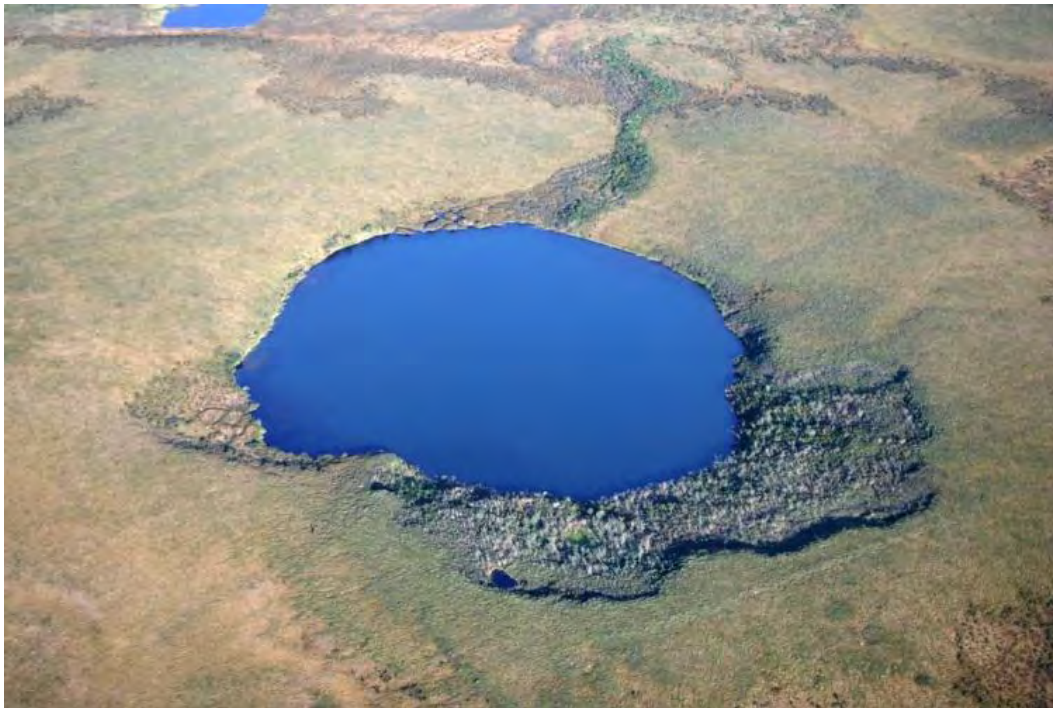
Photo A-2 Retrogressive thaw slumps west of KP 50

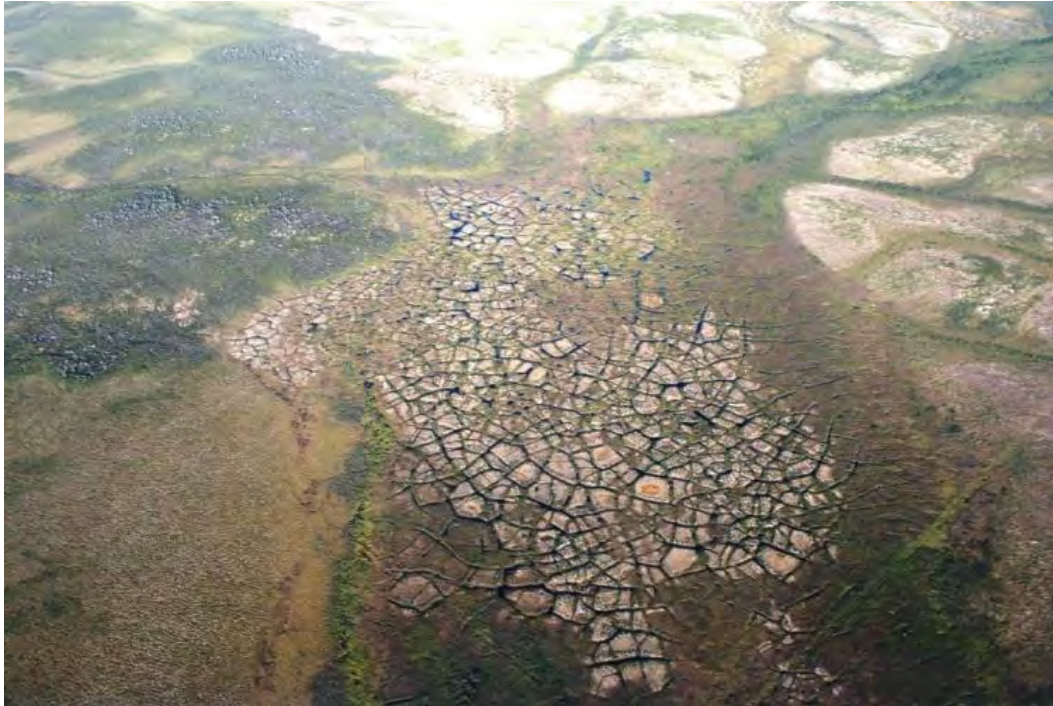
Photo A-3 Low center polygon near Borrow Source 2.45

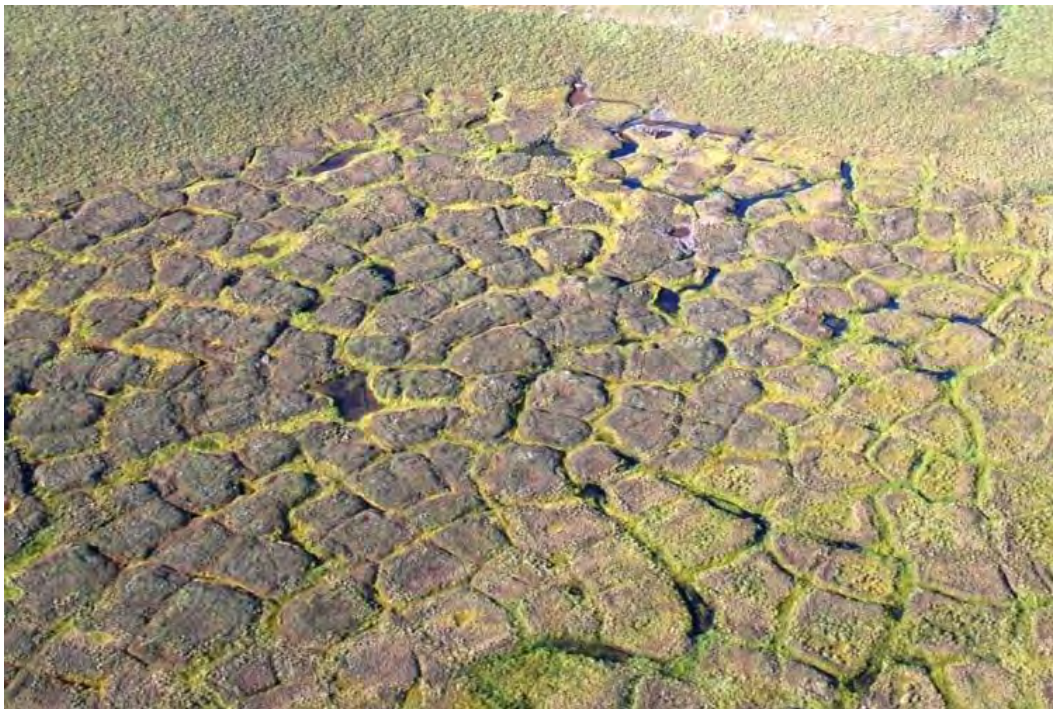
Photo A-4 High center polygon near KP 66

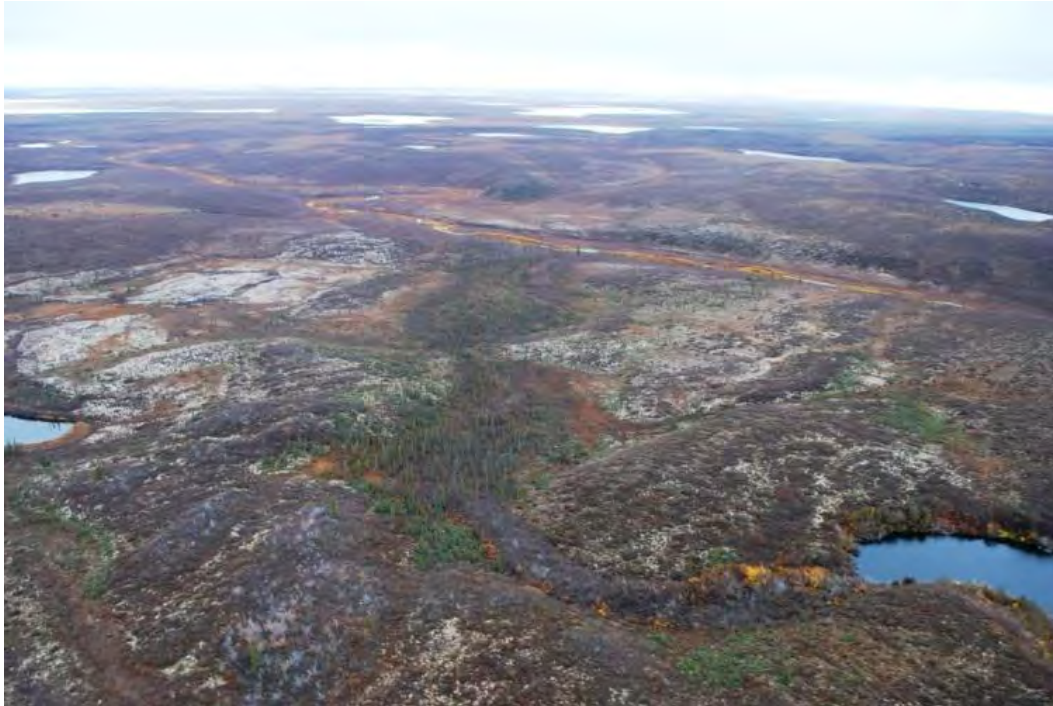
Photo A-5 Aerial oblique view of Borrow Source 2.45 (looking northeast)

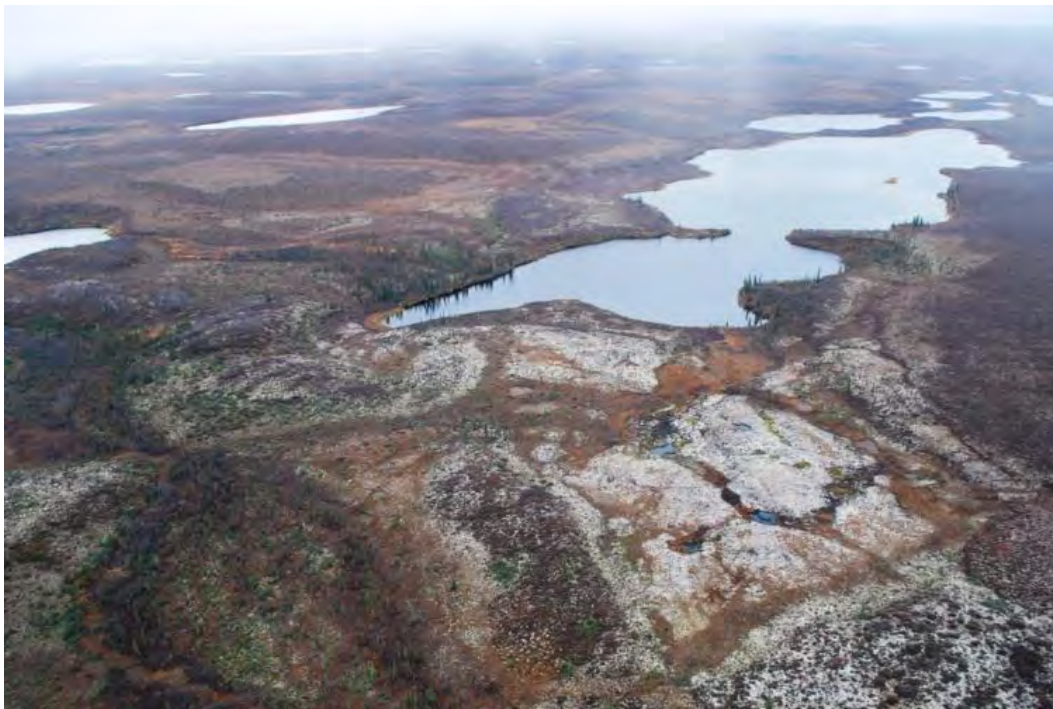
Photo A-6 Aerial oblique view of Borrow Source 2.45 (looking northwest)

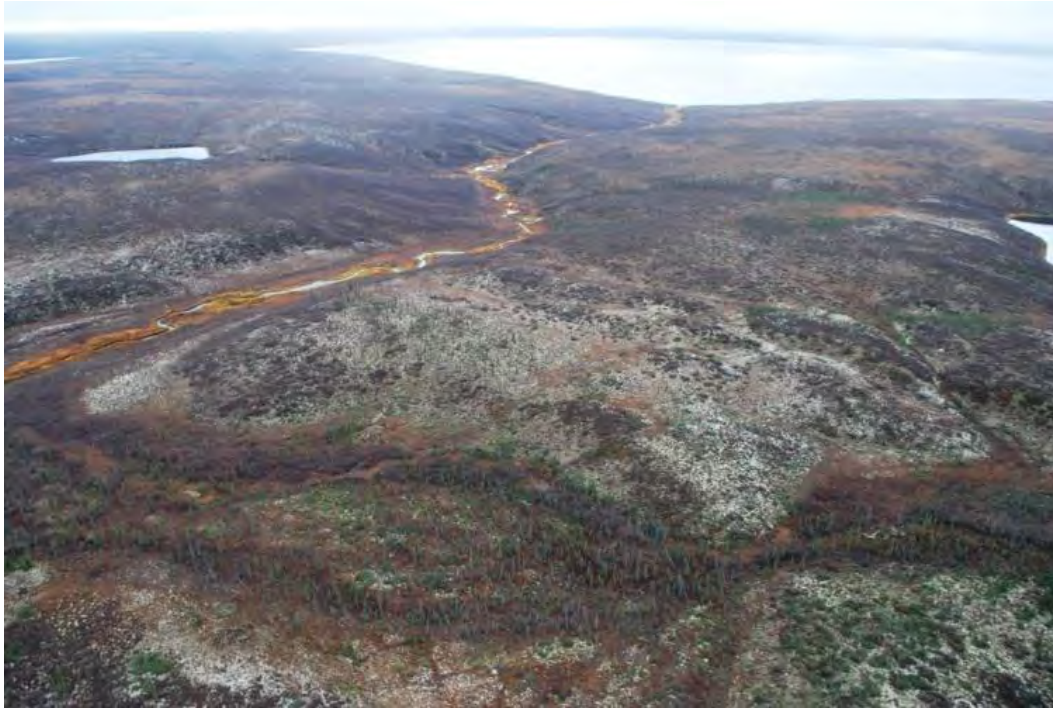
Photo A-7 Aerial oblique view of Borrow Source 2.45 (Noell Lake in the background)

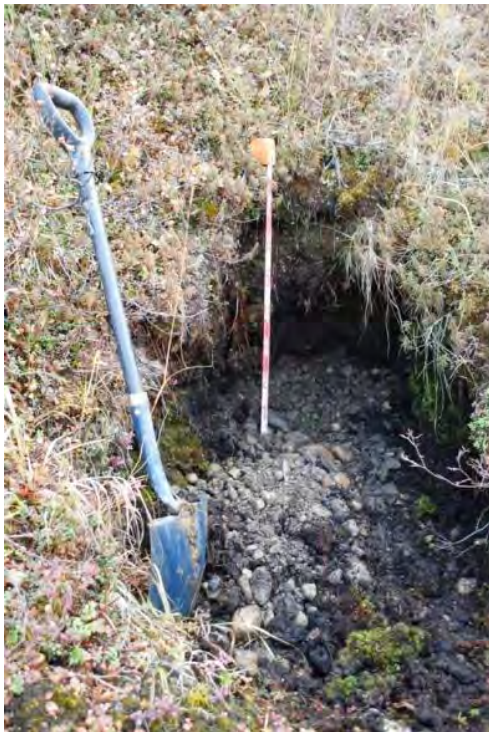
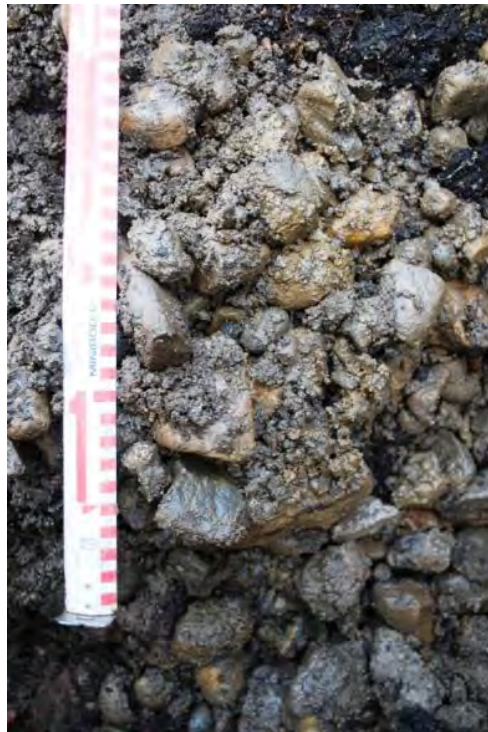
Photo A-8 Coarse-grained glaciofluvial material at Borrow Source 2.45

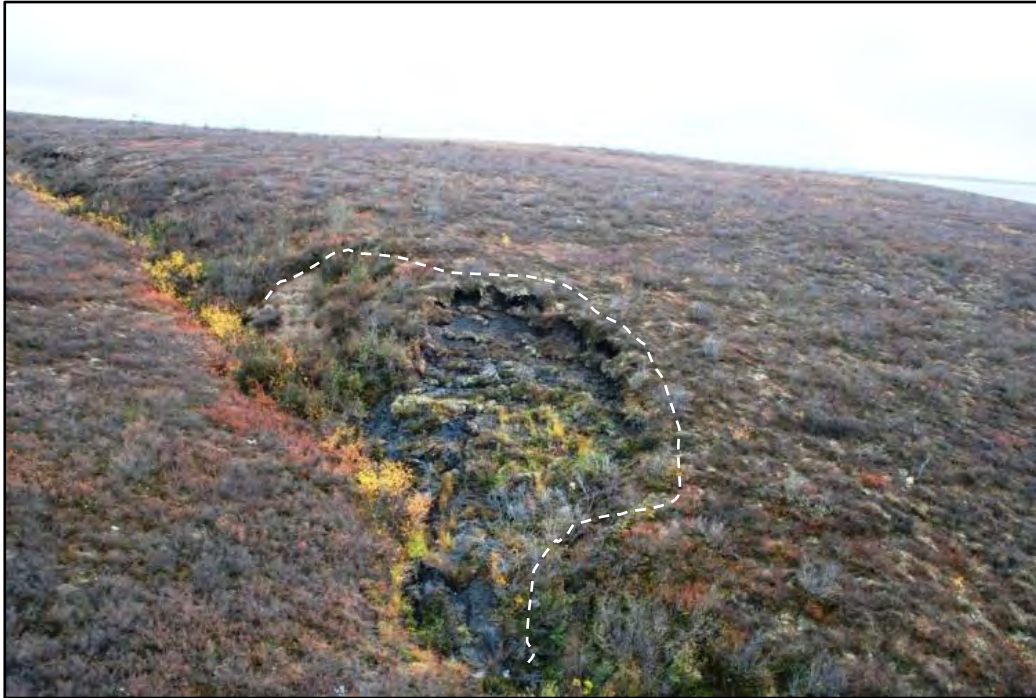
Photo A-9 Small active-layer detachment failure next to a gully at Borrow Source 2.45

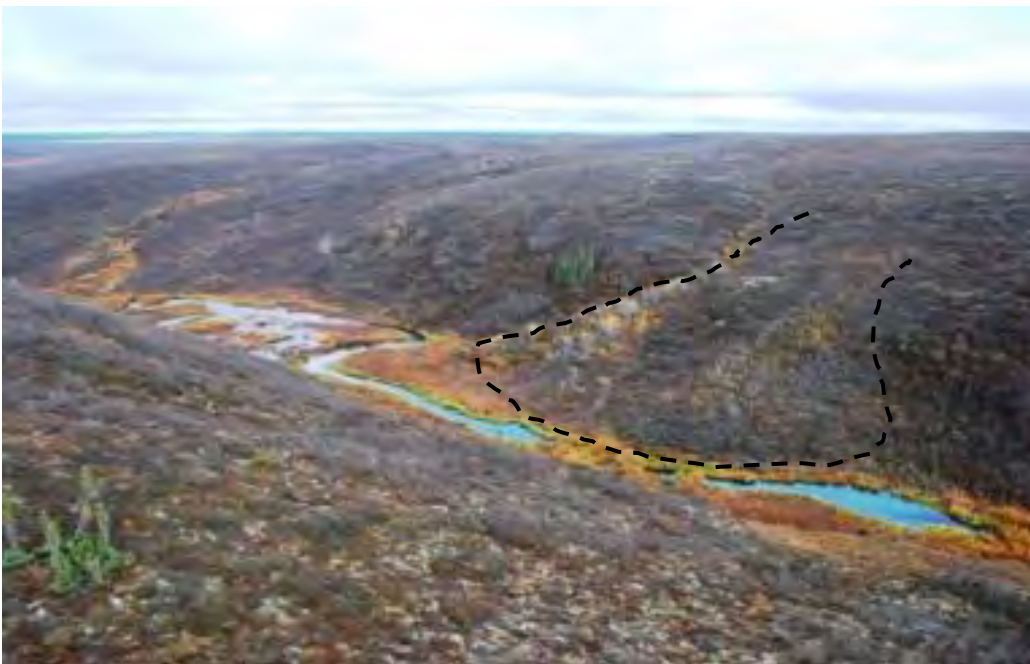
Photo A-10 Old stabilized slide (dashed line) along the eastern bank of a stream at Borrow Source 2.45 (looking northeast)

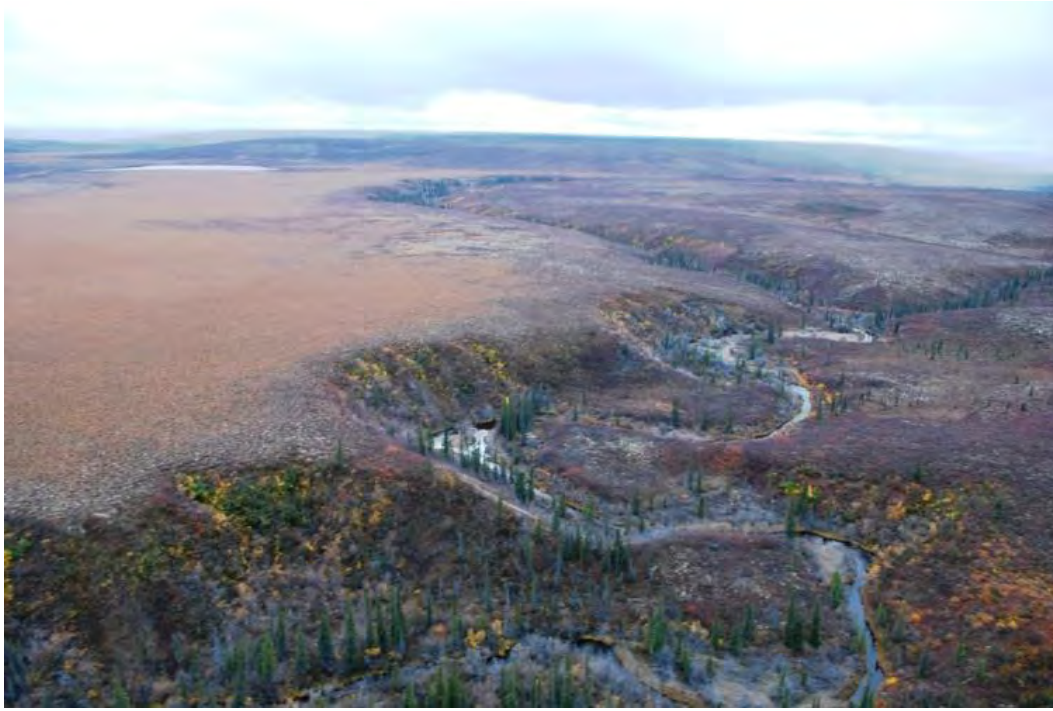
Photo A-11 Glaciofluvial terrace at Borrow Source 325 (looking west)

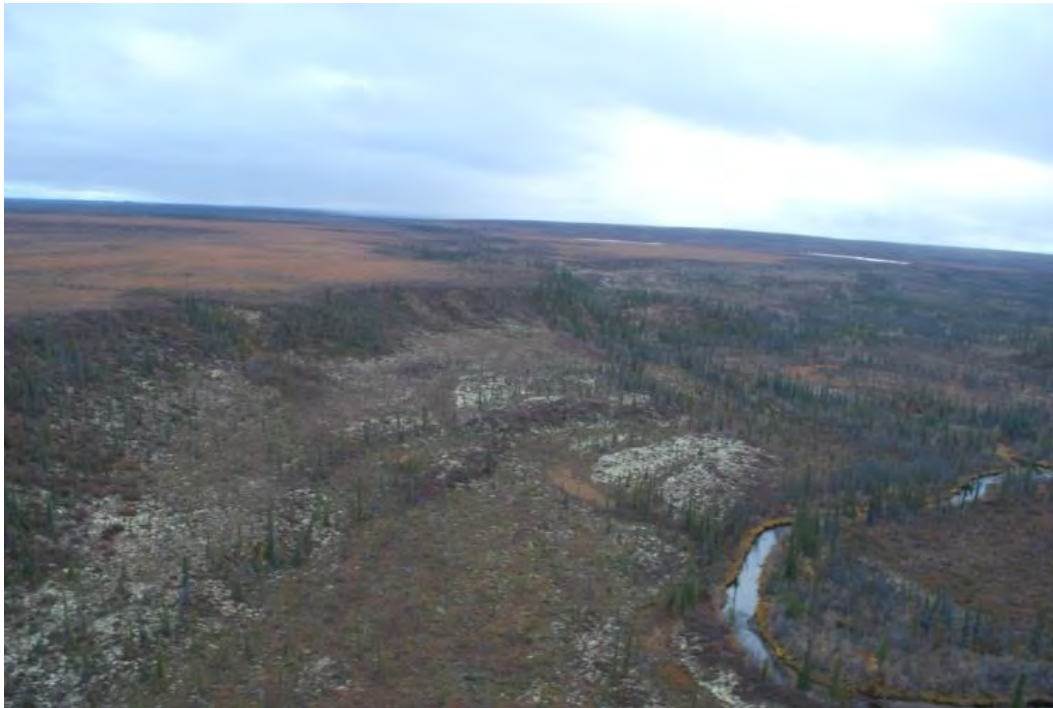
Photo A-12 Successive terraces at Borrow Source 325 (looking northwest)

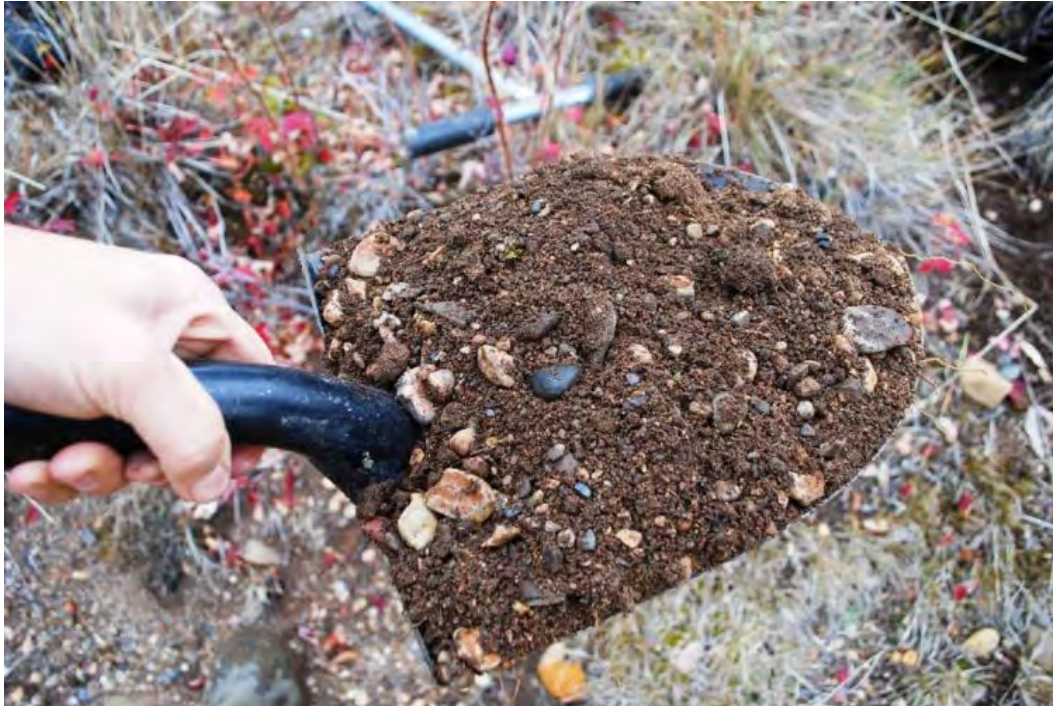
Photo A-13 Texture of glaciofluvial material at Borrow Source 325

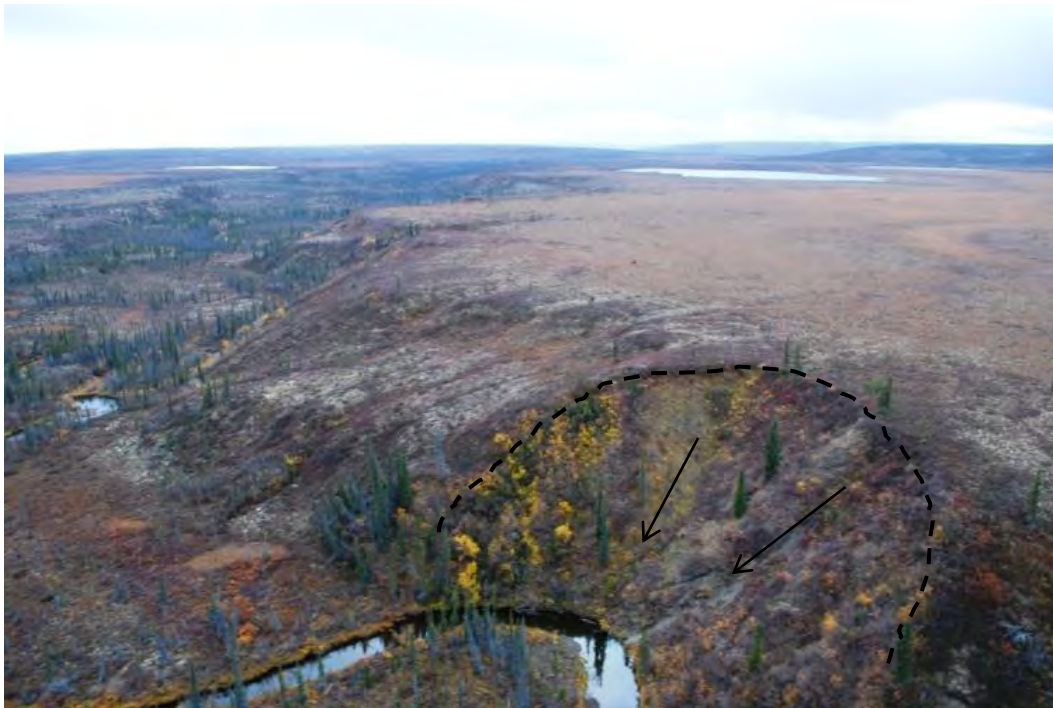
Photo A-14 Active slumping (dashed line) along the edge of a terrace at Borrow Source 325

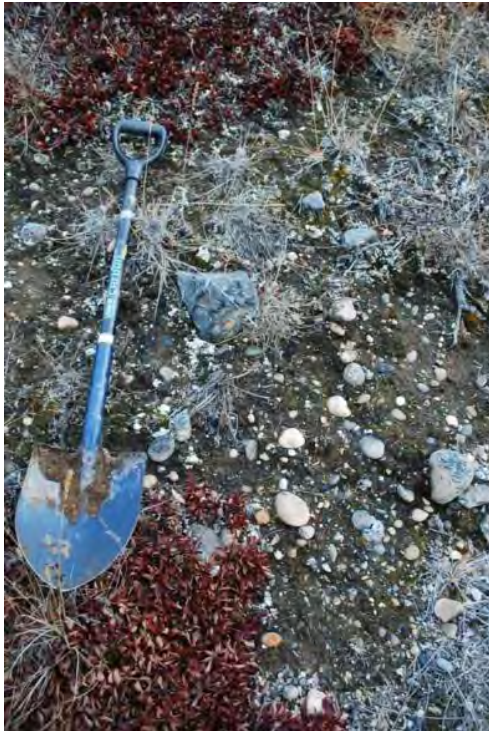
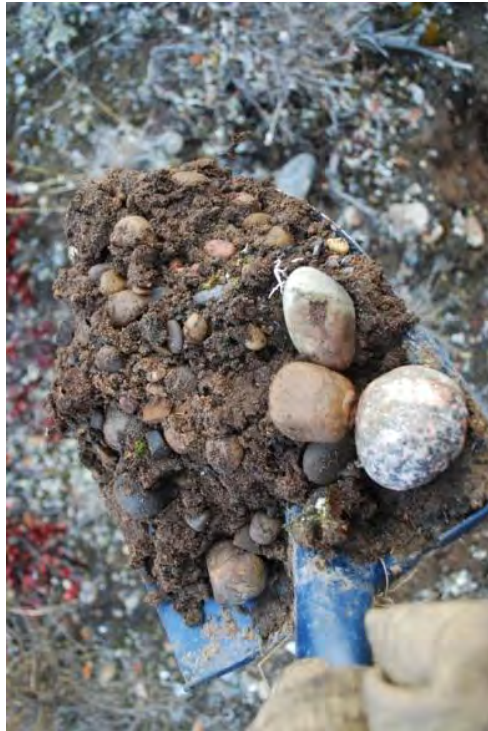
Photo A-16 Texture of glaciofluvial material at Borrow Source 172

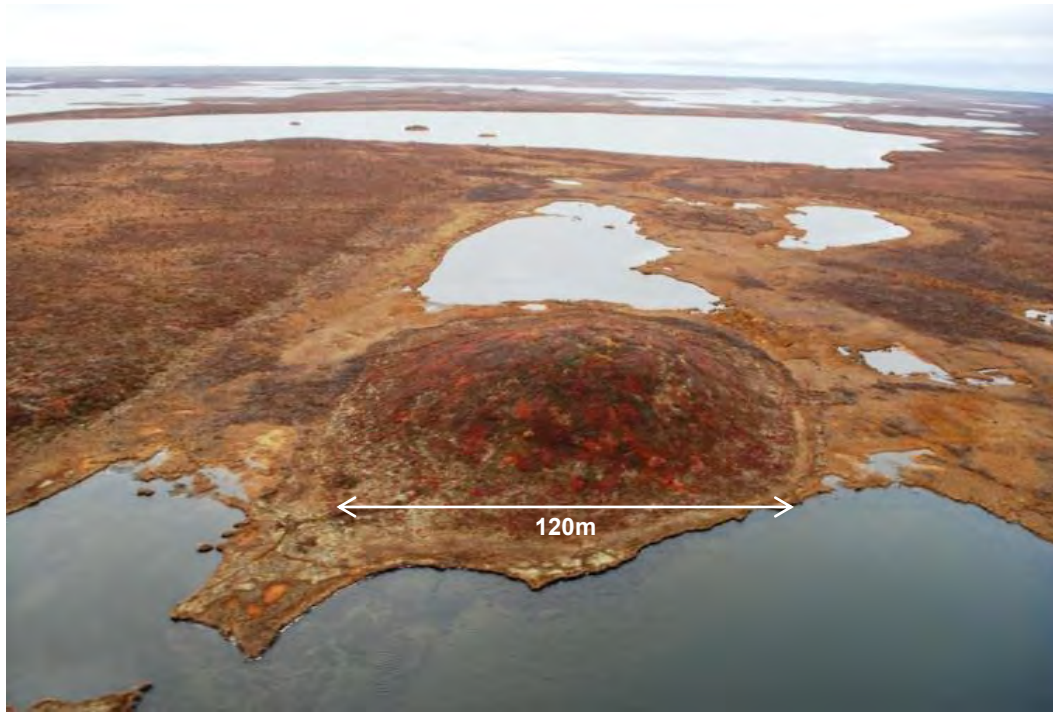
Photo A-17 Well developed pingo approximately 1km west of Alignment 1 at KP 93

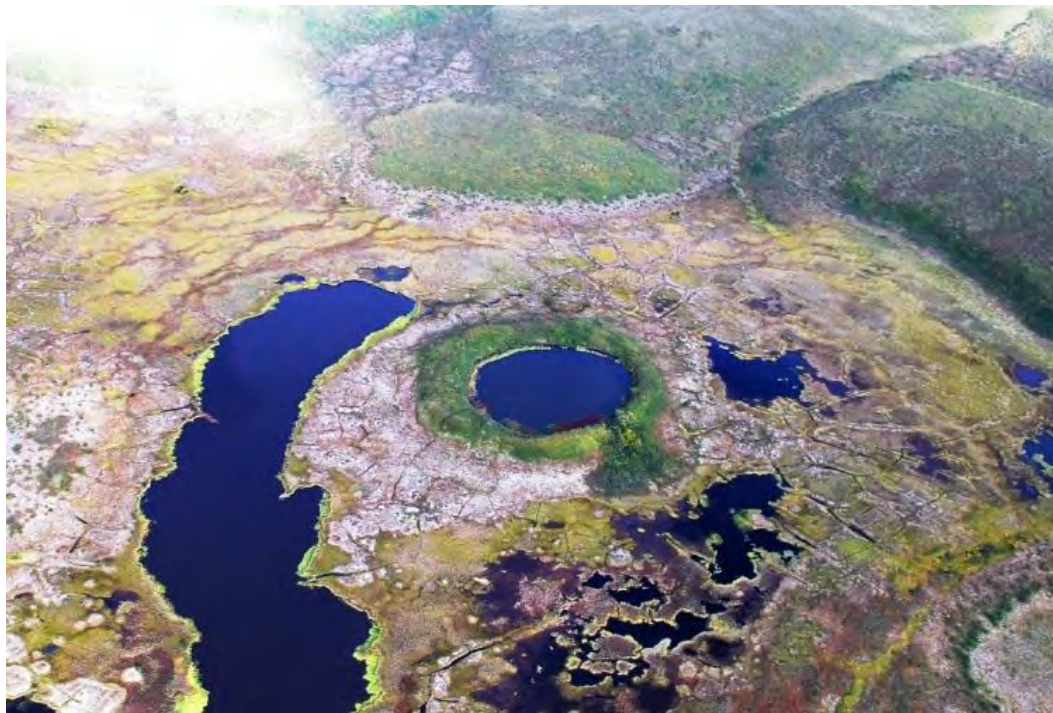
Photo A-18 Collapsed pingo
